KY DNR Flyrock Prevention Program

**Changing old ways of thinking re:
blaster's, mine management and
regulatory personnel**

2007 Fatality

**CAM MINING LLC
MINE NO. 1
FILE NO. 9984-63
FATAL ACCIDENT**

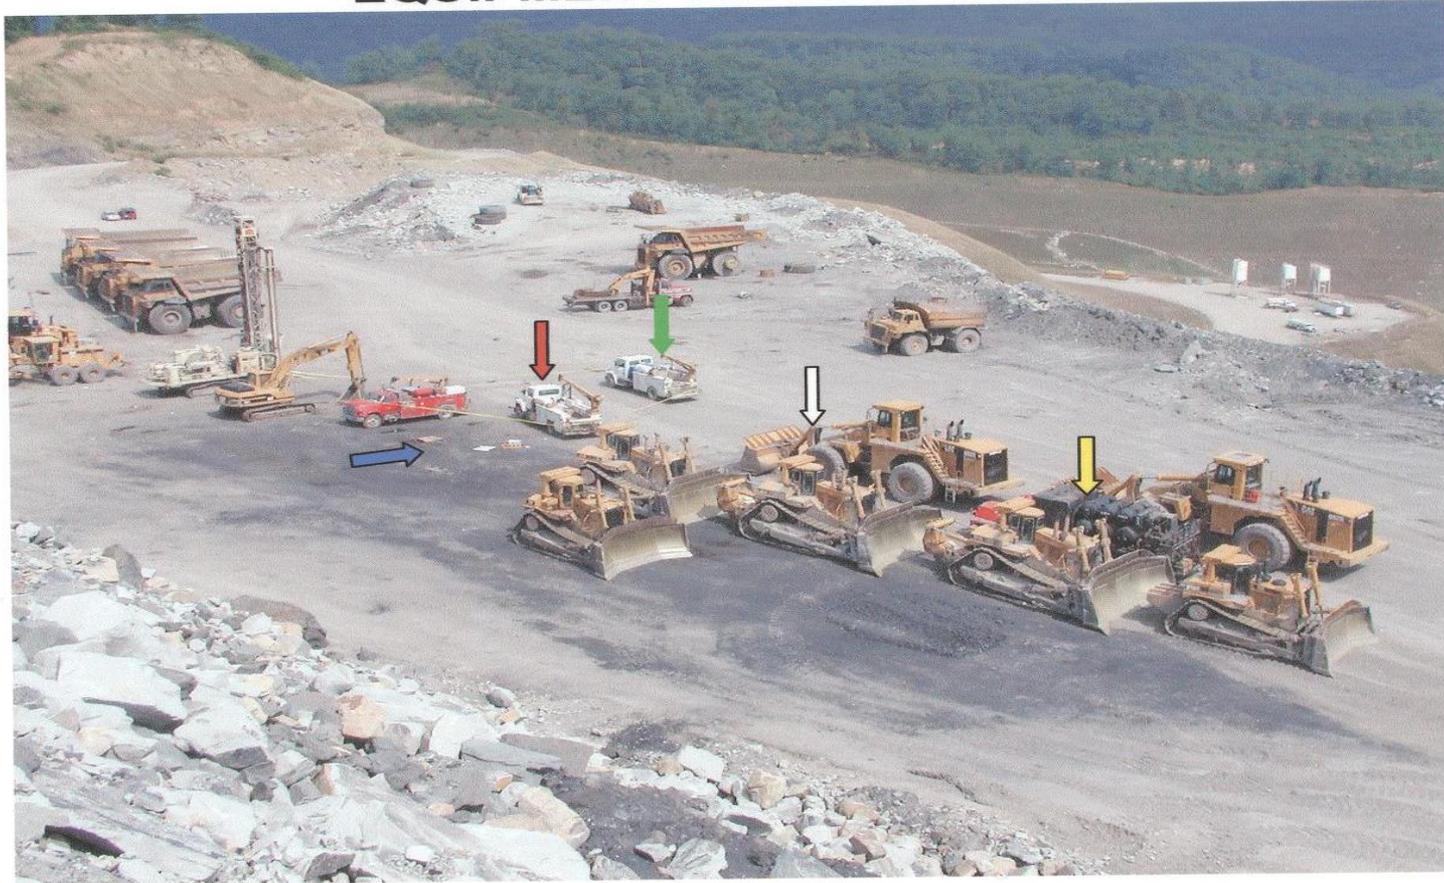
**RED ARROW INDICATES THE APPROXIMATE LOCATION
OF THE VICTIM - BOBBY MESSER**

YELLOW ARROW INDICATES THE LOCATION OF TERRY ADAMS, JR.

GREEN ARROW INDICATES THE LOCATION OF WILLIAM HOLBROOK

WHITE ARROW INDICATES THE LOCATION OF DELMON ADAMS

**BLUE ARROW INDICATES WHERE THE FLYROCK IMPACTED THE GROUND;
THE FLYROCK TRAVELED 1570 FEET FROM THE LEFT SIDE OF PHOTO AREA**

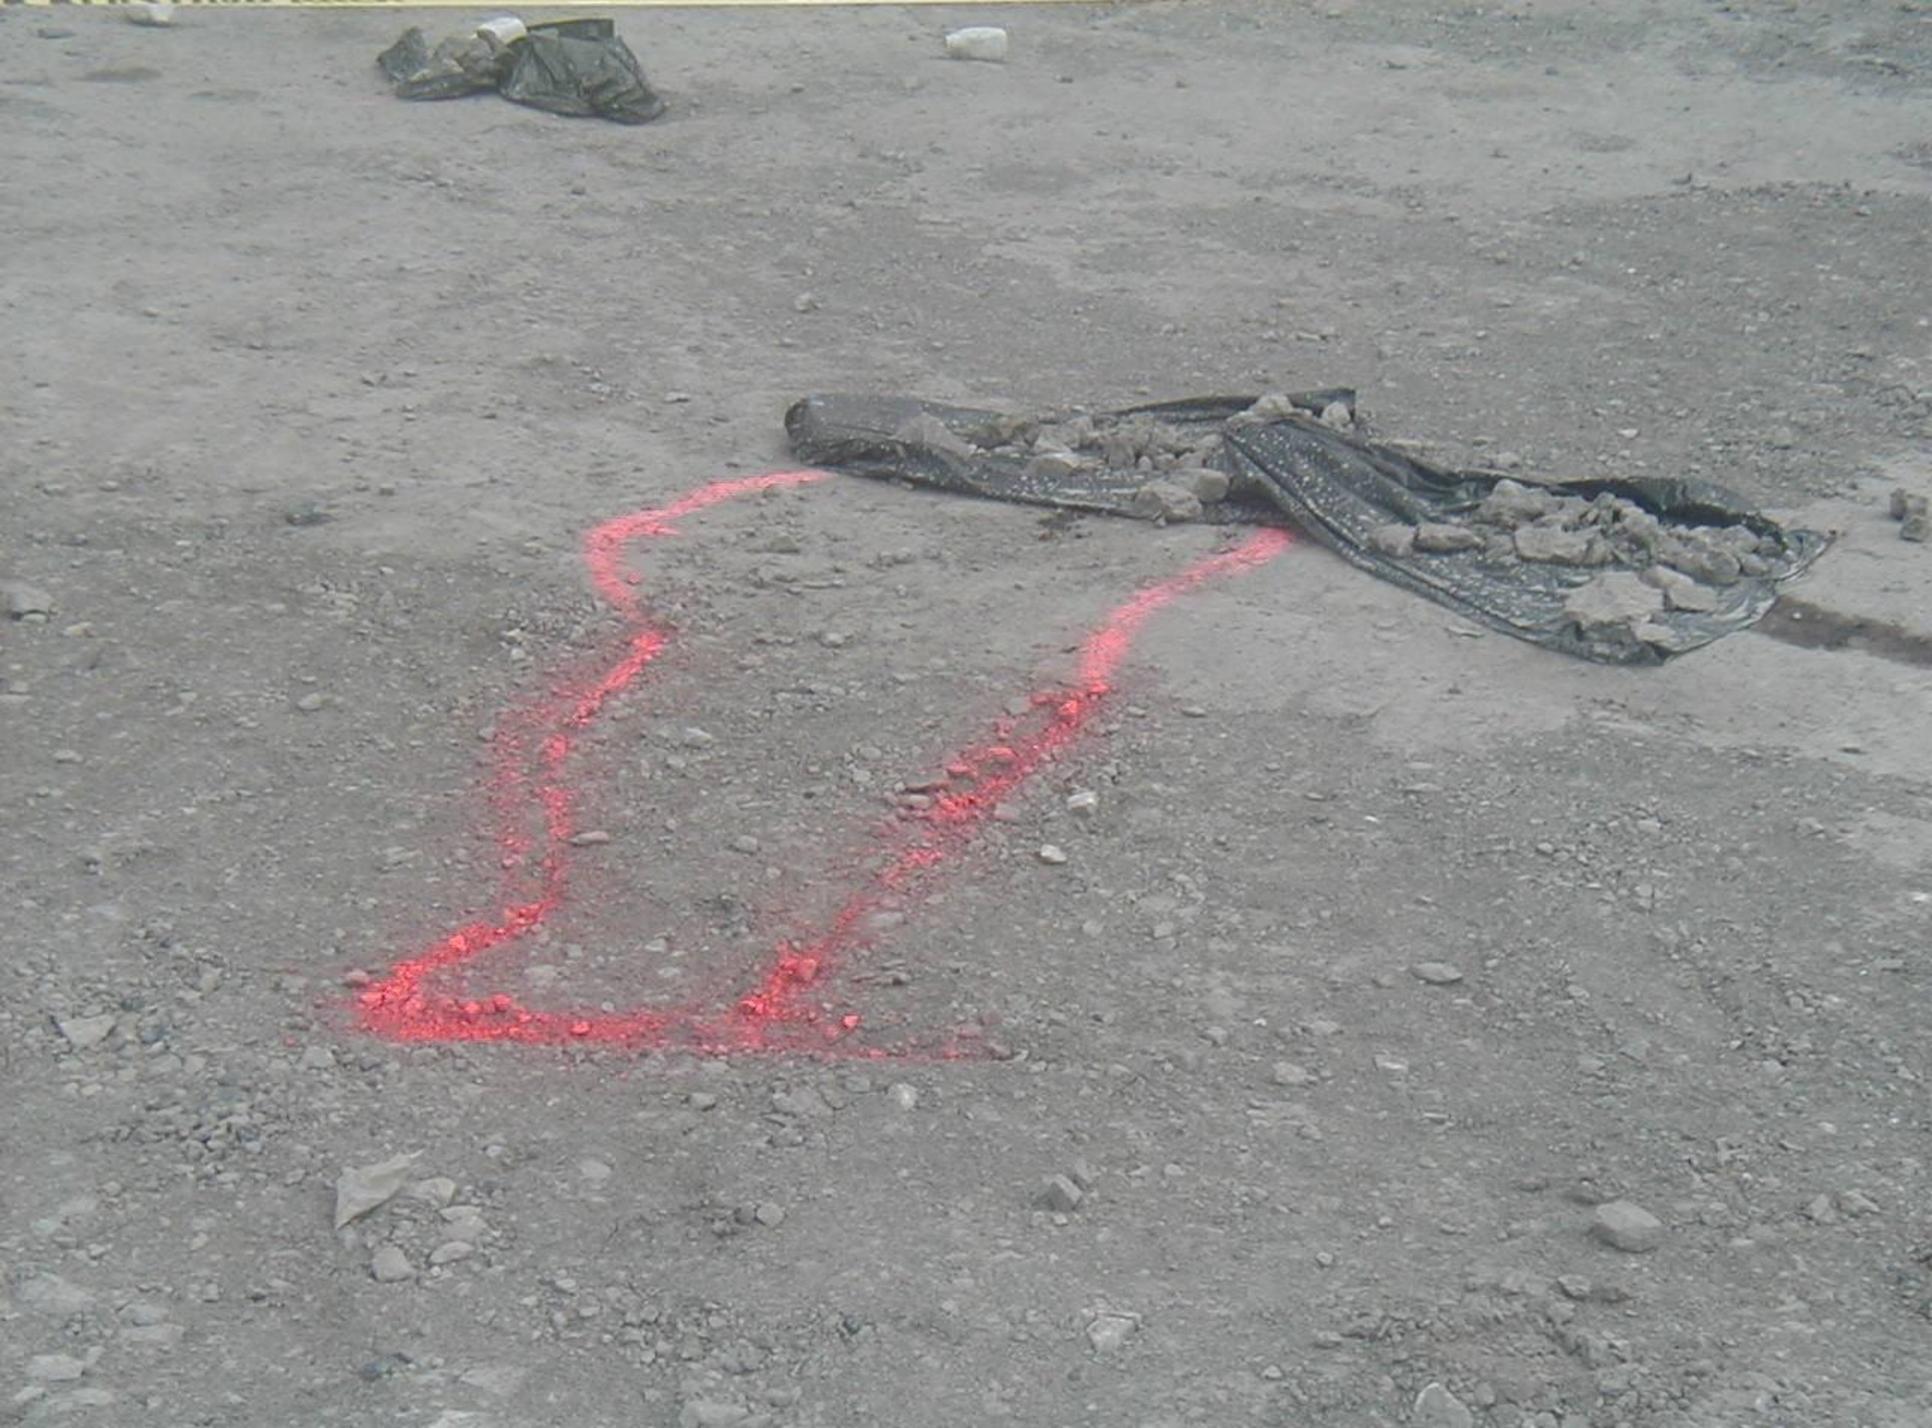
SKETCH NO.3

Depression in gravel made by impact of flyrock

ALL THE ROCKS AT THE ACCIDENT SCENE ARE CONSISTANT WITH THE TYPE OF SANDSTONE THAT WAS AT THE NO. 1 SHOT.

THE LARGEST FRAGMENT OF ROCK FOUND FROM THE IMPACT AREA MEASURED 15"L x 5"W x 7"T. THIS ROCK STRUCK THE CAB AND BOOM OF THE NO.801 MECHANIC TRUCK.

SLIDE MARKS WERE PRESENT FOR 17' 8" AND APPARENTLY MADE BY THE VICTIM.

IMPACT AREA OF THE LARGE FLYROCK FROM THE NO.1 SHOT MEASURED 20"W x 19"L x 3.5"D. THE ROCK BROKE INTO SEVERAL FRAGMENTS UPON IMPACT.

A SEPERATE FLYROCK THAT WAS NOT A FRAGMENT FROM THE IMPACT AREA.

ROCKS FOUND AT THE ACCIDENT SCENE - FRAGMENTS FROM A LARGE FLYROCK THAT LANDED AT THE IMPACT AREA.

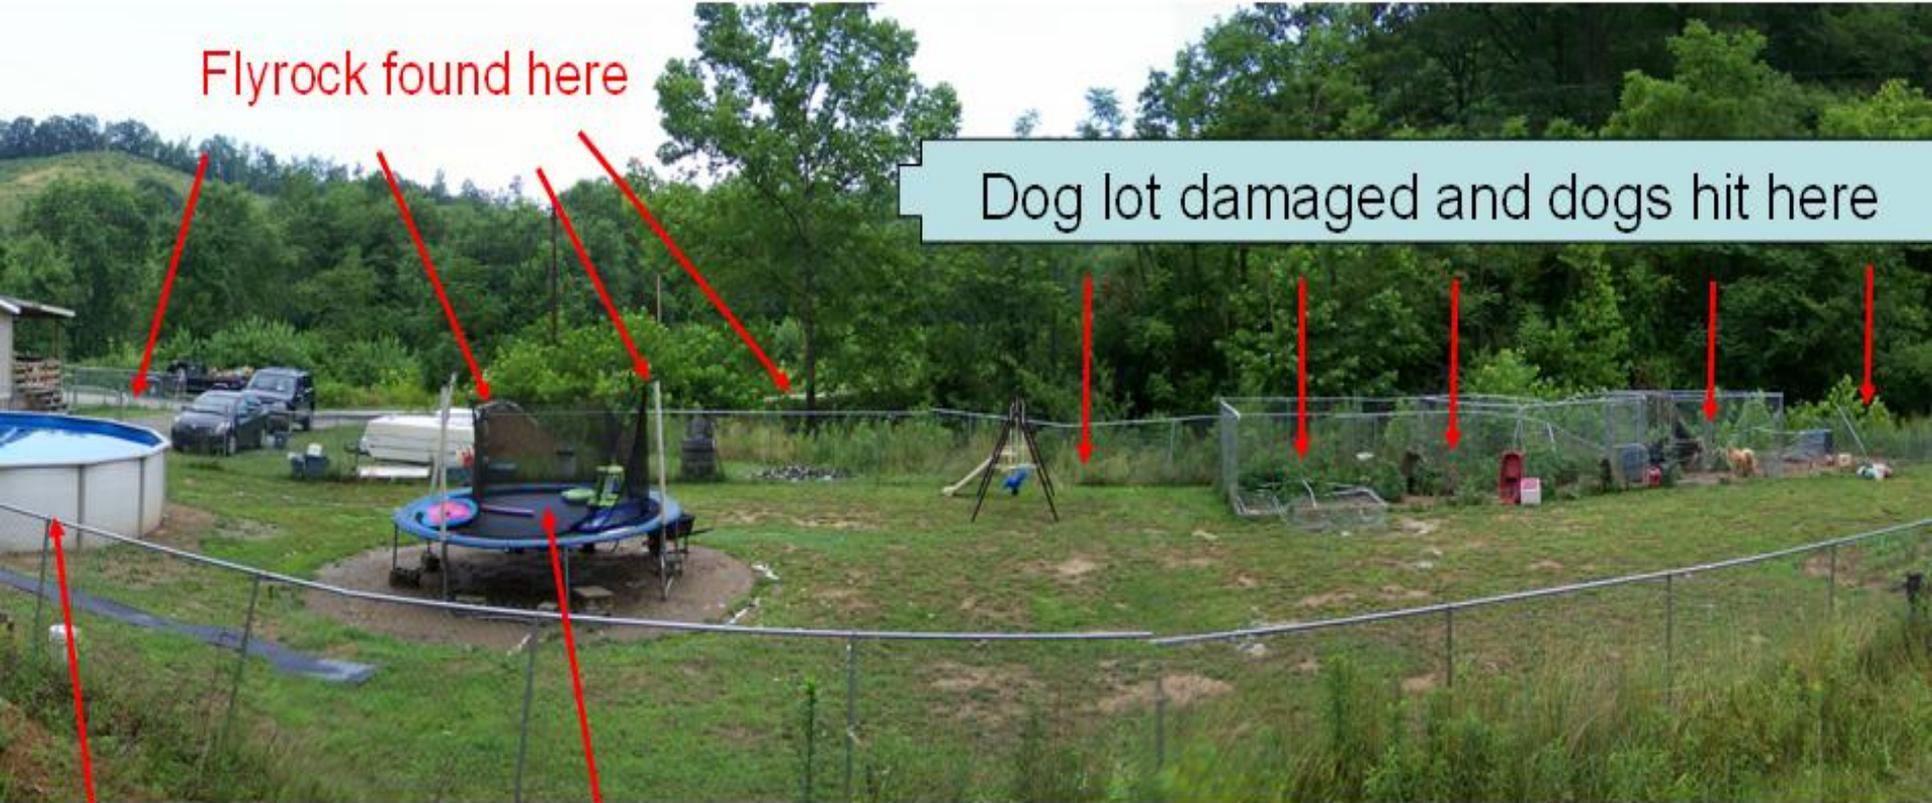
Hole in trampoline

Flyrock found here

Dog lot damaged and dogs hit here

Flyrock in pool and through trampoline

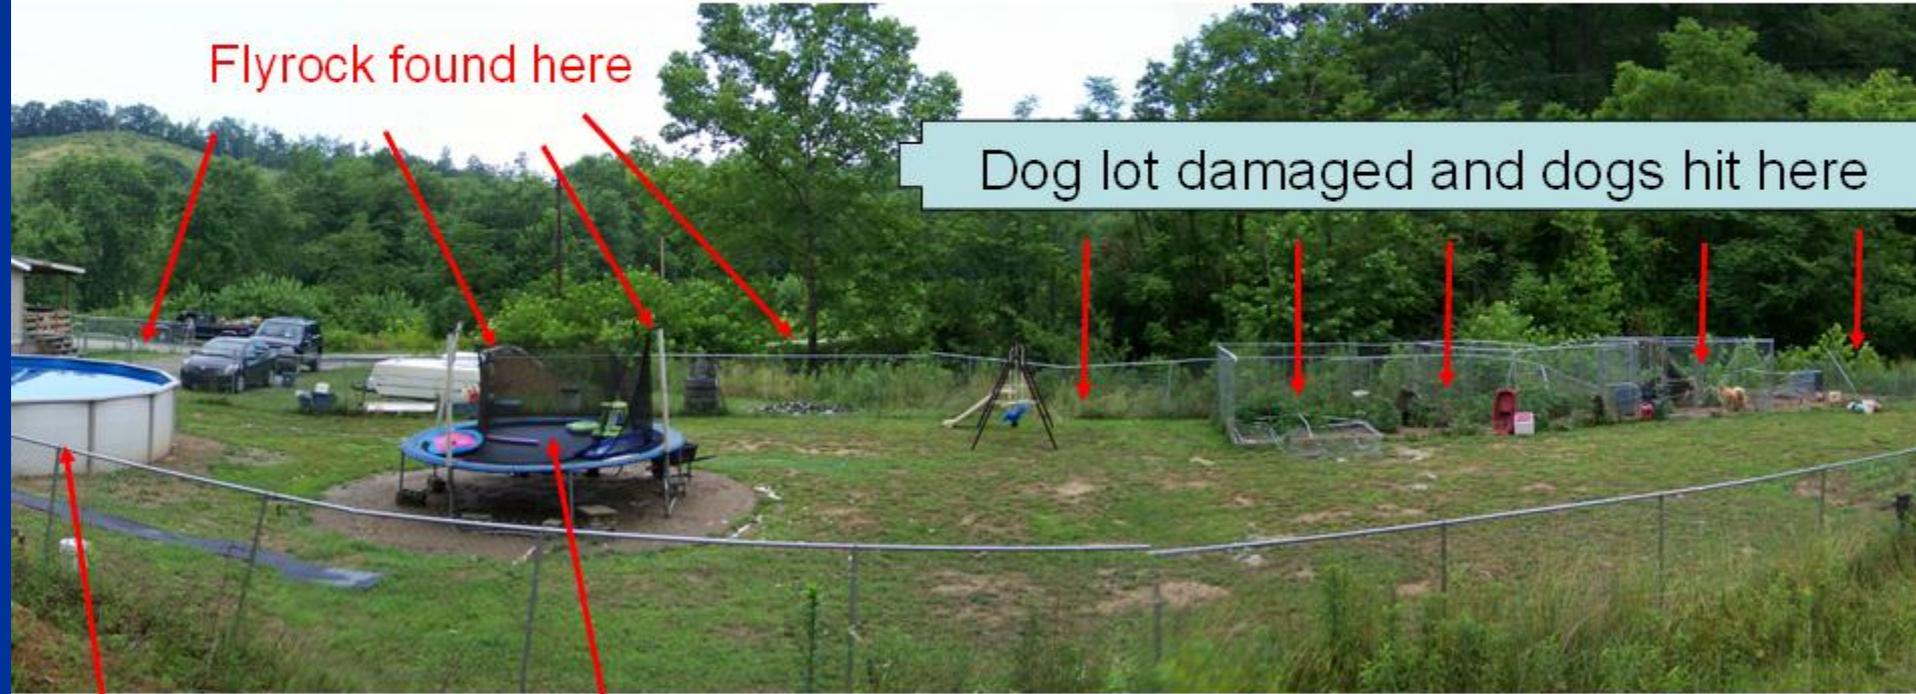
Flyrock found here

Dog lot damaged and dogs hit here

Flyrock in pool and through trampoline
