# **Tailings System Safety Review for the Quirke Tailings Management Area in Elliot Lake**

Shiu N. Kam (Golder Associates Ltd.)  
Maxine A. Wiber (Rio Algom Limited)  
Roger A. Payne (Consultant)  
John B. Davis (Golder Associates Ltd.)  
Donald E. Welch (Golder Associates Ltd.)

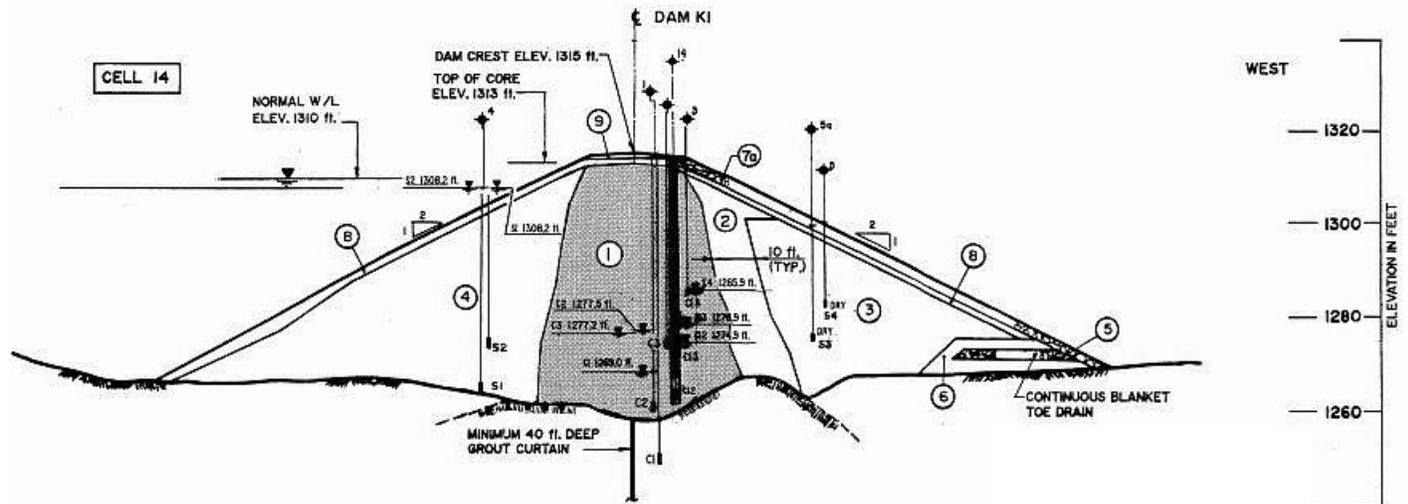
Figure 3. Typical Dam Cross Section, Dam K1.

All of the perimeter dams are zoned embankments with low-permeability (glacial till) central cores. Figure 3 shows a typical perimeter dam cross-section (Dam K1). The dam shells are constructed of granular materials. The internal dykes were constructed over old rockfill dykes founded on tailings. They are designed to retain tailings and to reduce seepage through the dyke.

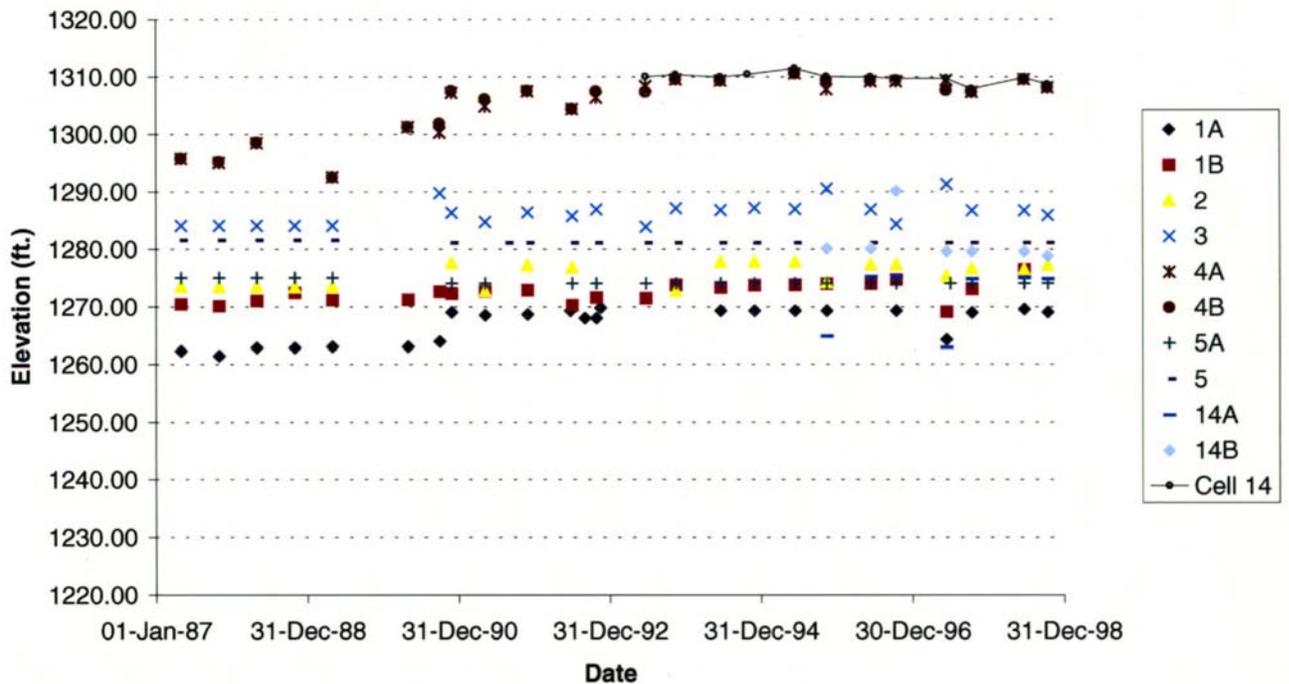
Figure 4. Piezometric Water Levels, Dam K1

The observed piezometric water levels are stable and consistent with the assumptions made during the design. Typical pore water condition in a dam founded on bedrock is shown on Figure 4.
