Using Mobile GIS to Protect and Inspect Cultural Resources at the El Segundo Mine, NM

Dave Clark

NM Mining and Minerals Division

APR 26 2006

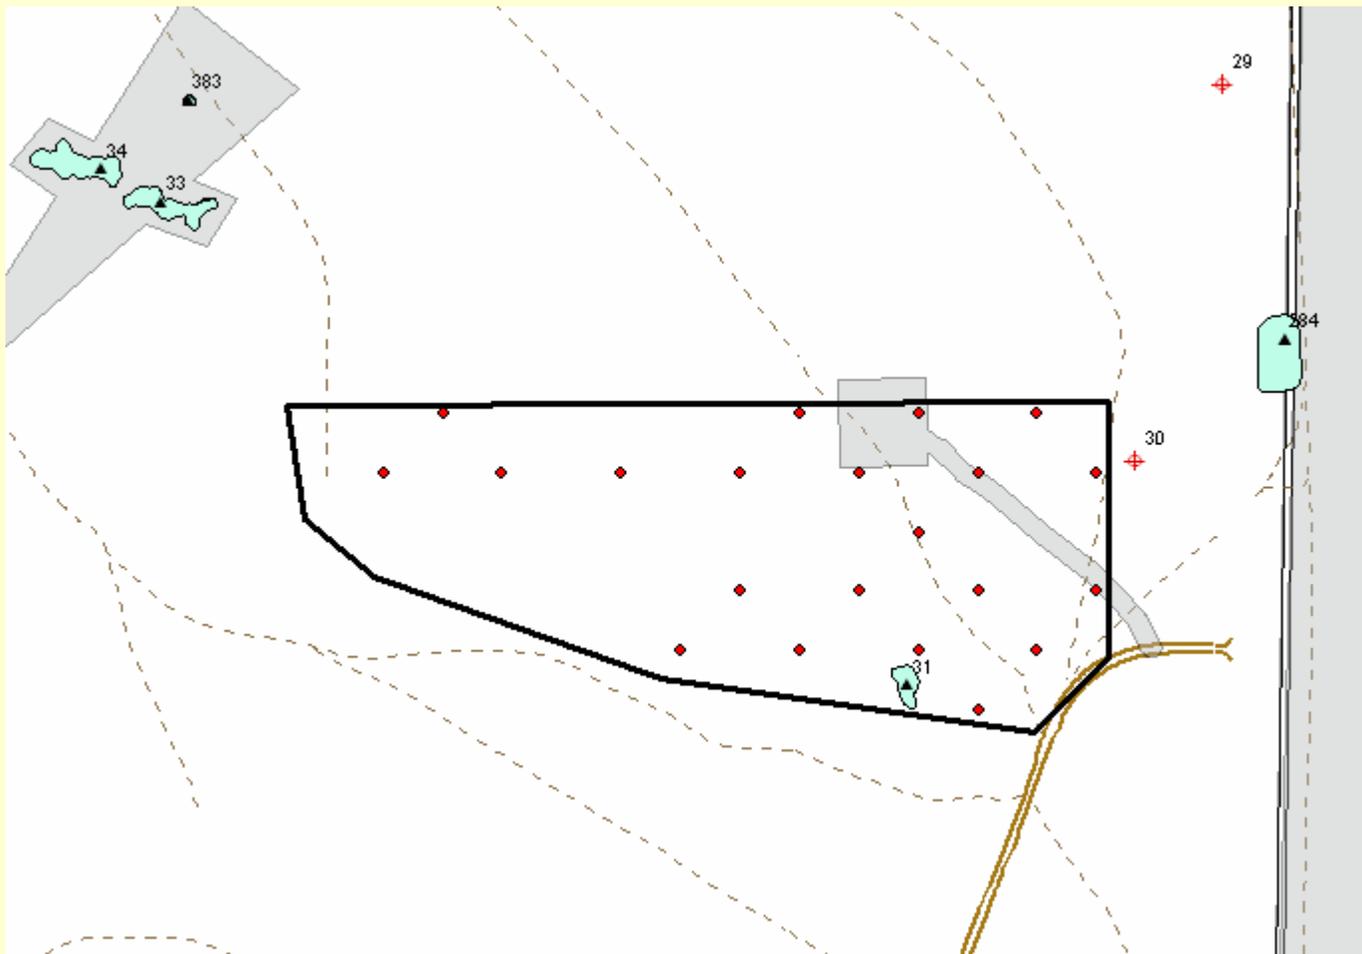
Zooming in on a boxcut area, we see the drill hole pattern in red and archeology site 31, in close proximity to the drilling activity (the county road adjacent to the drilling block will be re-located prior to mining).

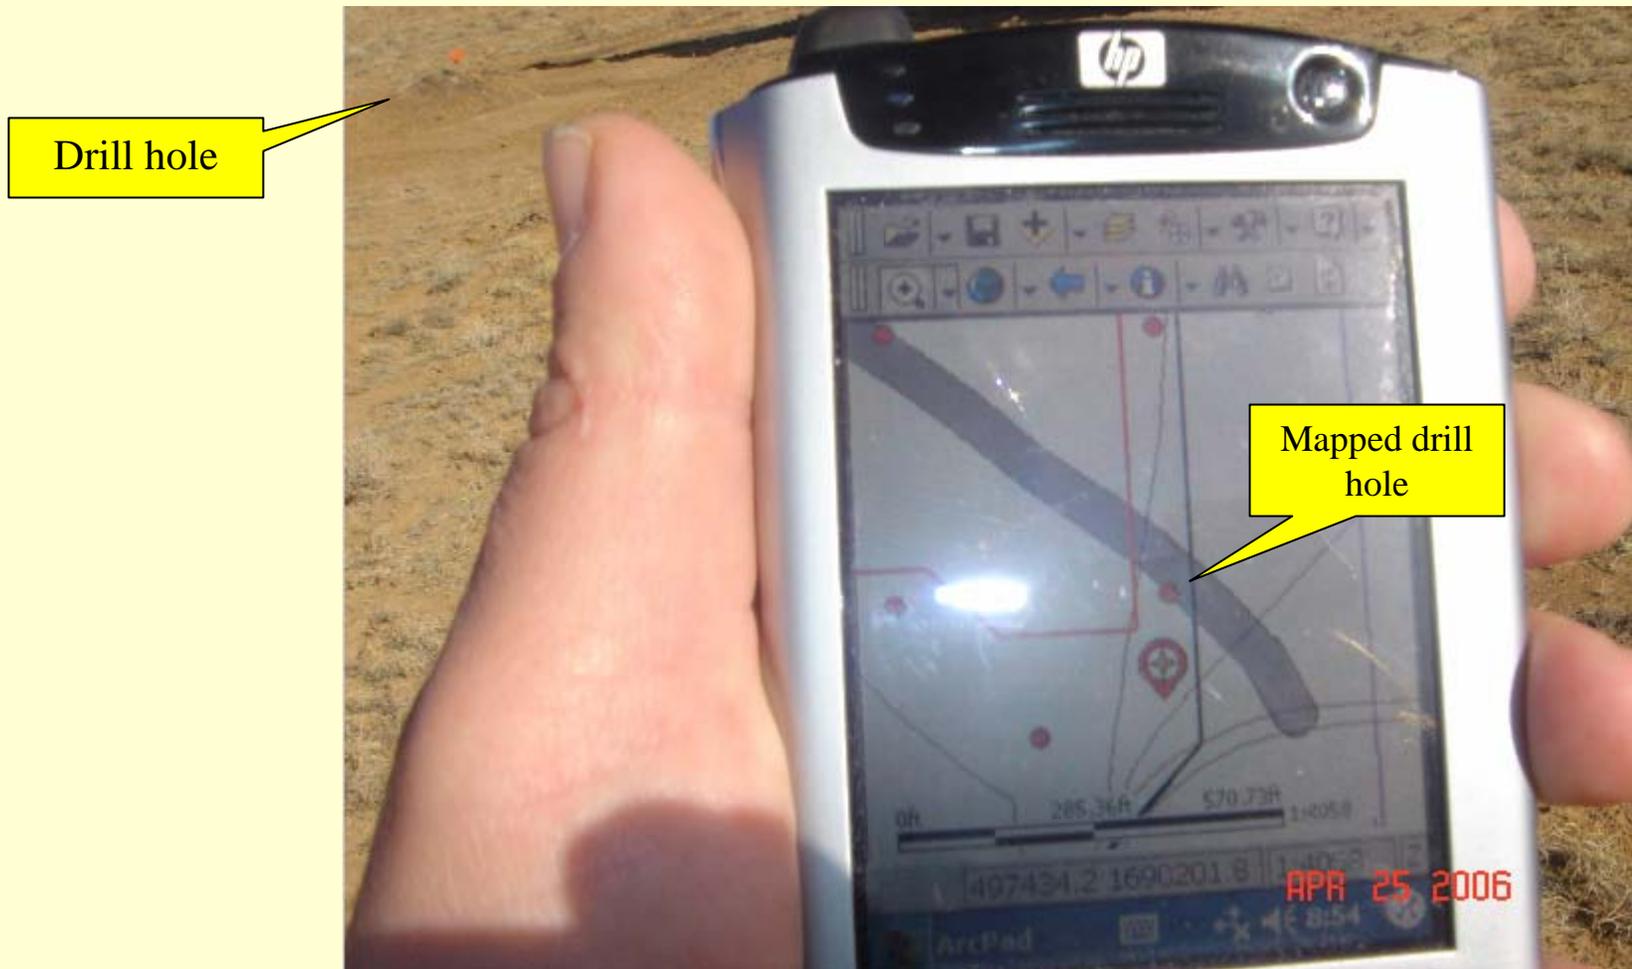
So the archeologists proceed in front of the drillers and mitigate sites within the boxcut areas. My job is to verify initially that the drill holes have not been located directly on the arch sites, and in the field that the access routes and drilling activity have not impacted nearby sites. Below, I am approaching a drill hole in a boxcut area near a county road and Hwy 509. A wireless GPS receiver is indicating my position on an ArcPad map on my pocket PC.

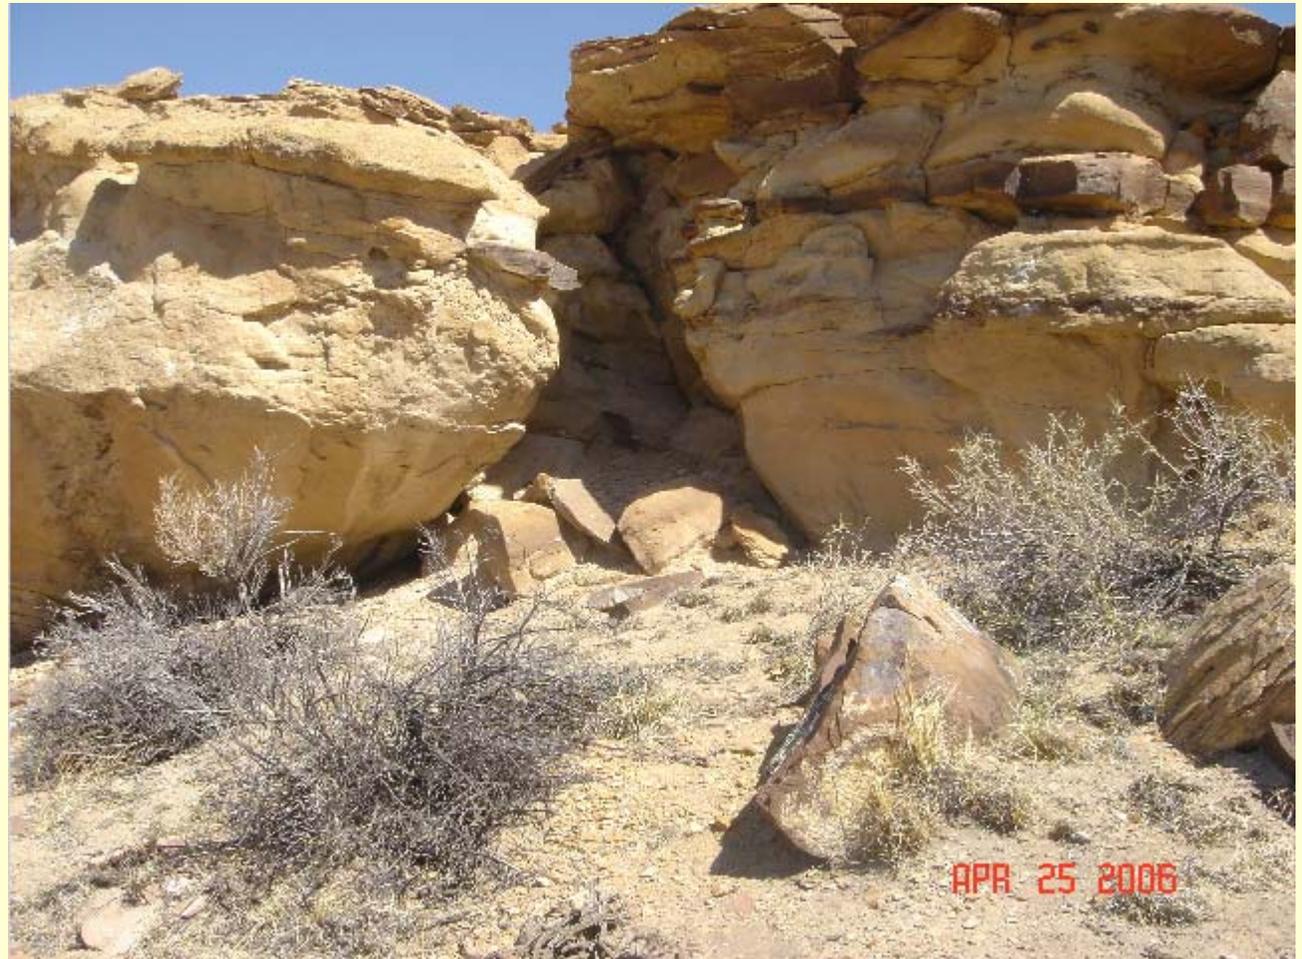
This was the most dramatic cultural resource site that I visited...categorized by the archeologists as a habitation...but when I was there it was only inhabited by a rattlesnake, and this is as close as I got.
