MSHA Perspective

Abandoned Coal Mines

Impoundment Breakthrough Incidents

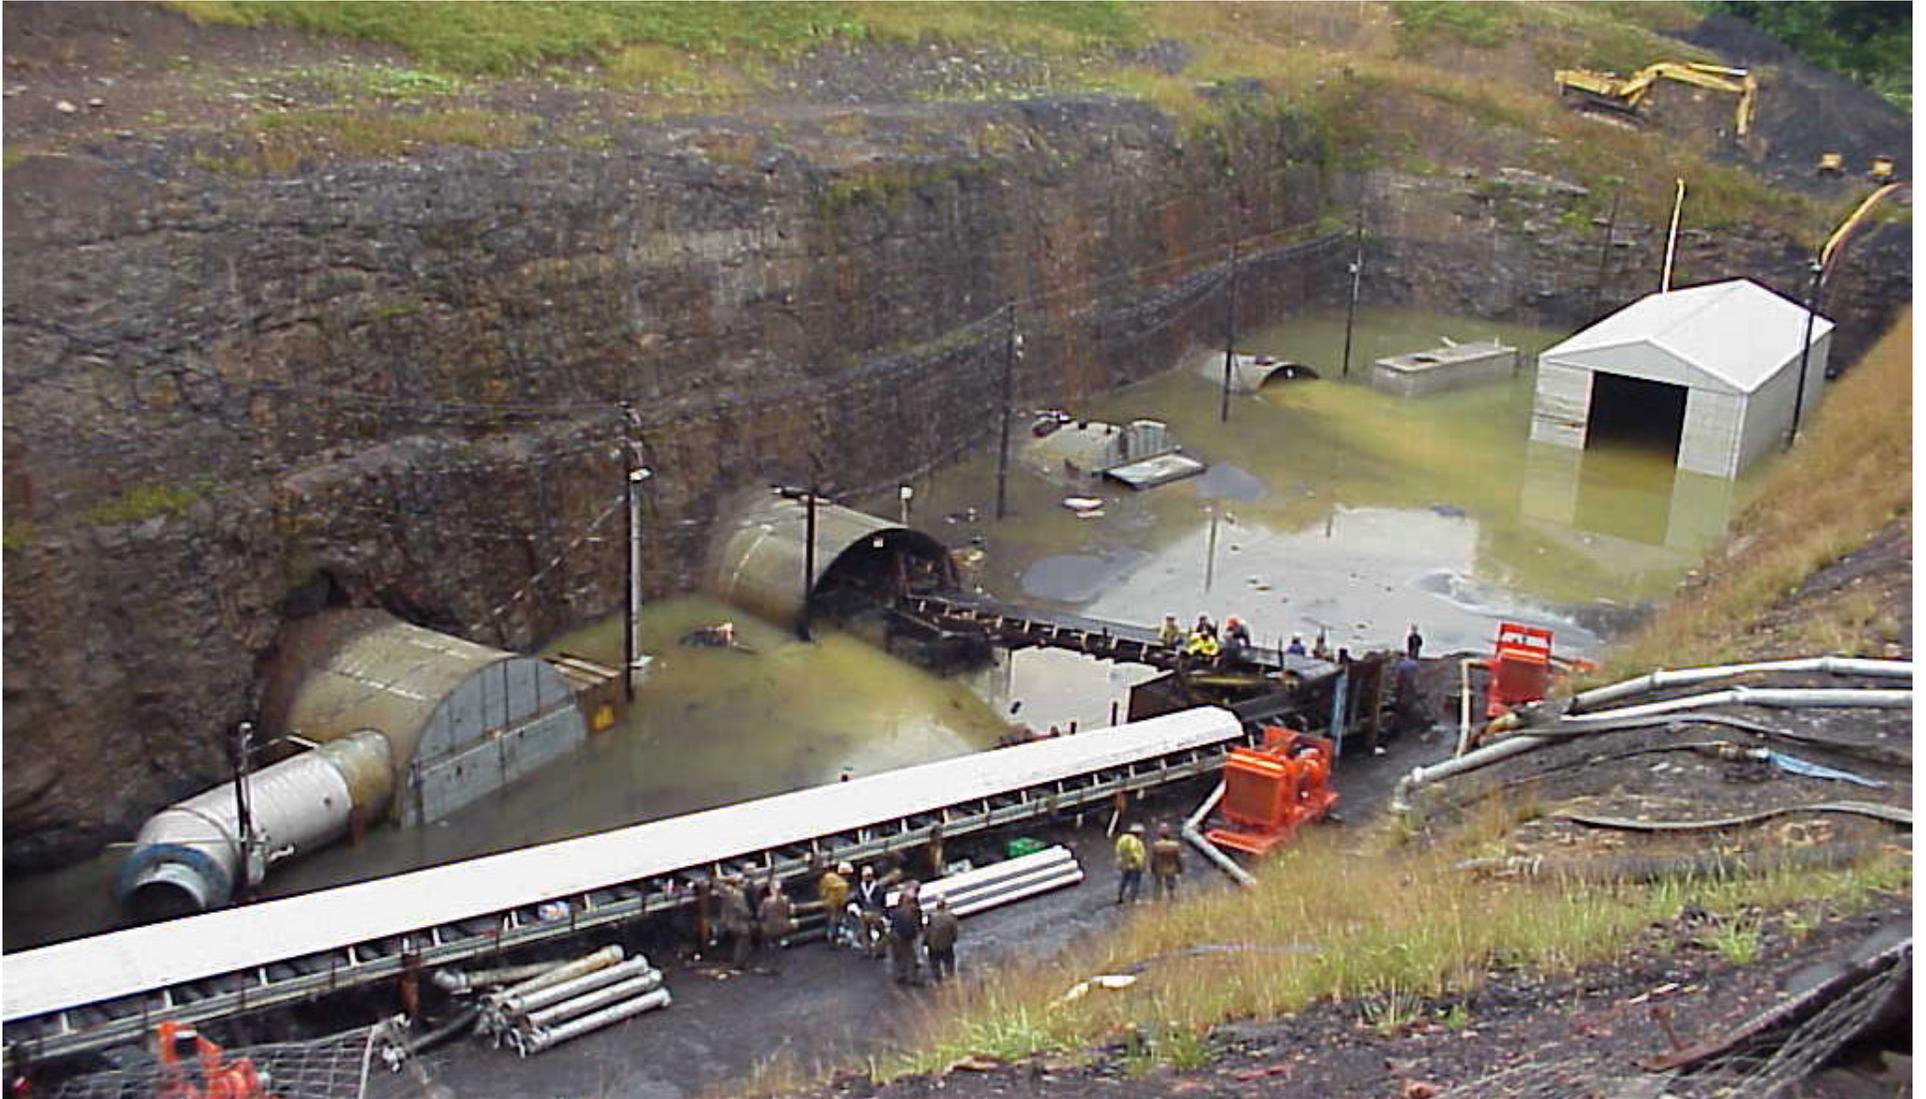
Notable Example: Quecreek Mine Inundation Accident, July, 2002

- From 1995 through June 2002, mine operators reported 181 mine inundations.
- Of these, at least 107 were unplanned cut-throughs that resulted in water inundations.

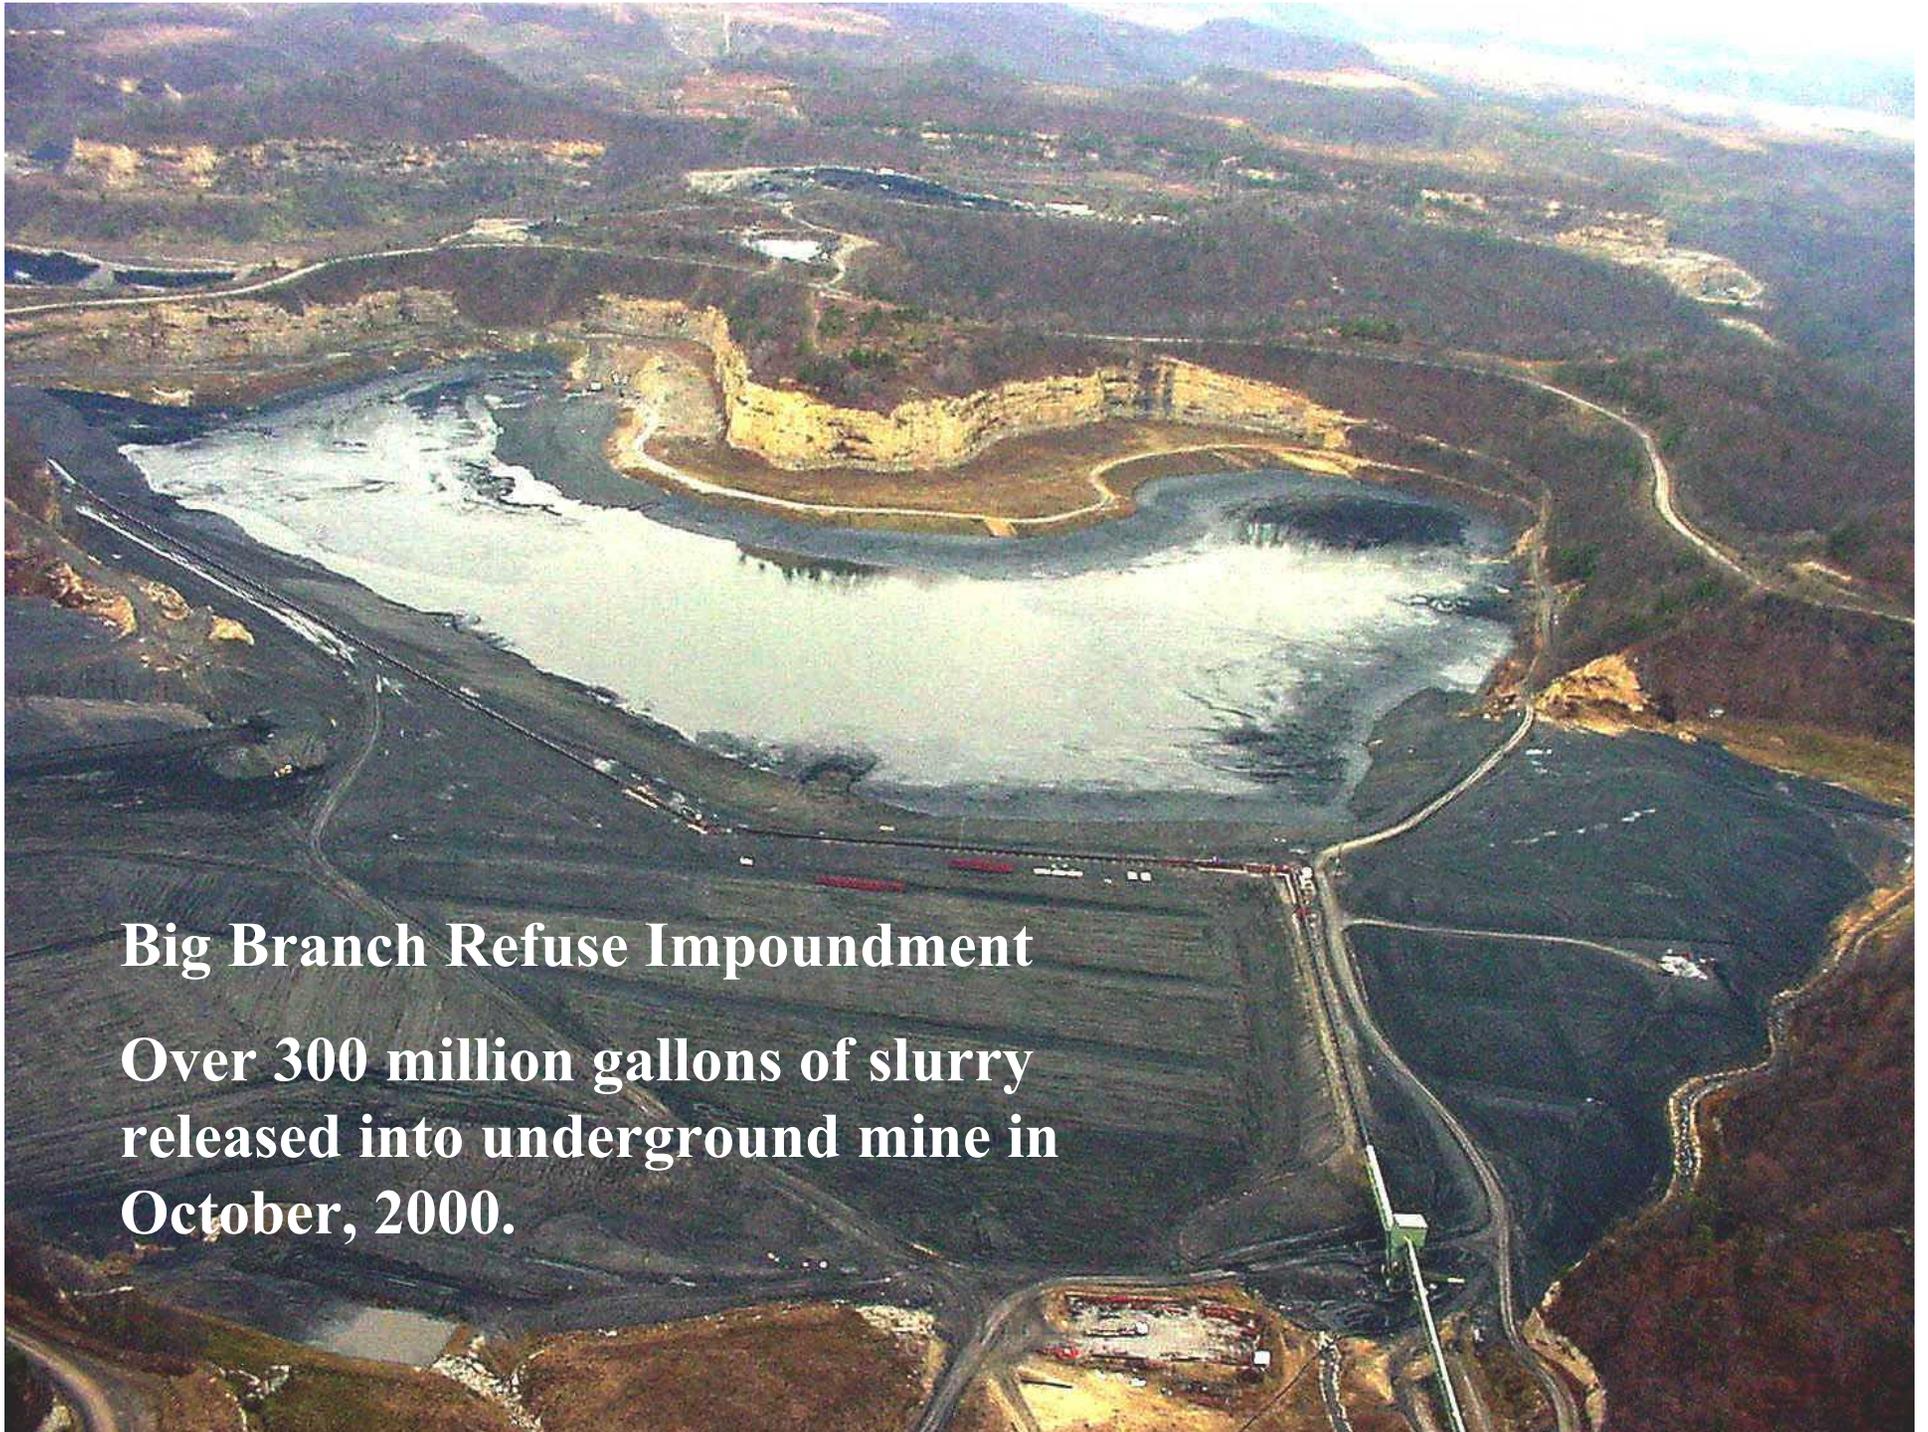
Big Branch Refuse Impoundment

**Over 300 million gallons of slurry
released into underground mine in
October, 2000.**

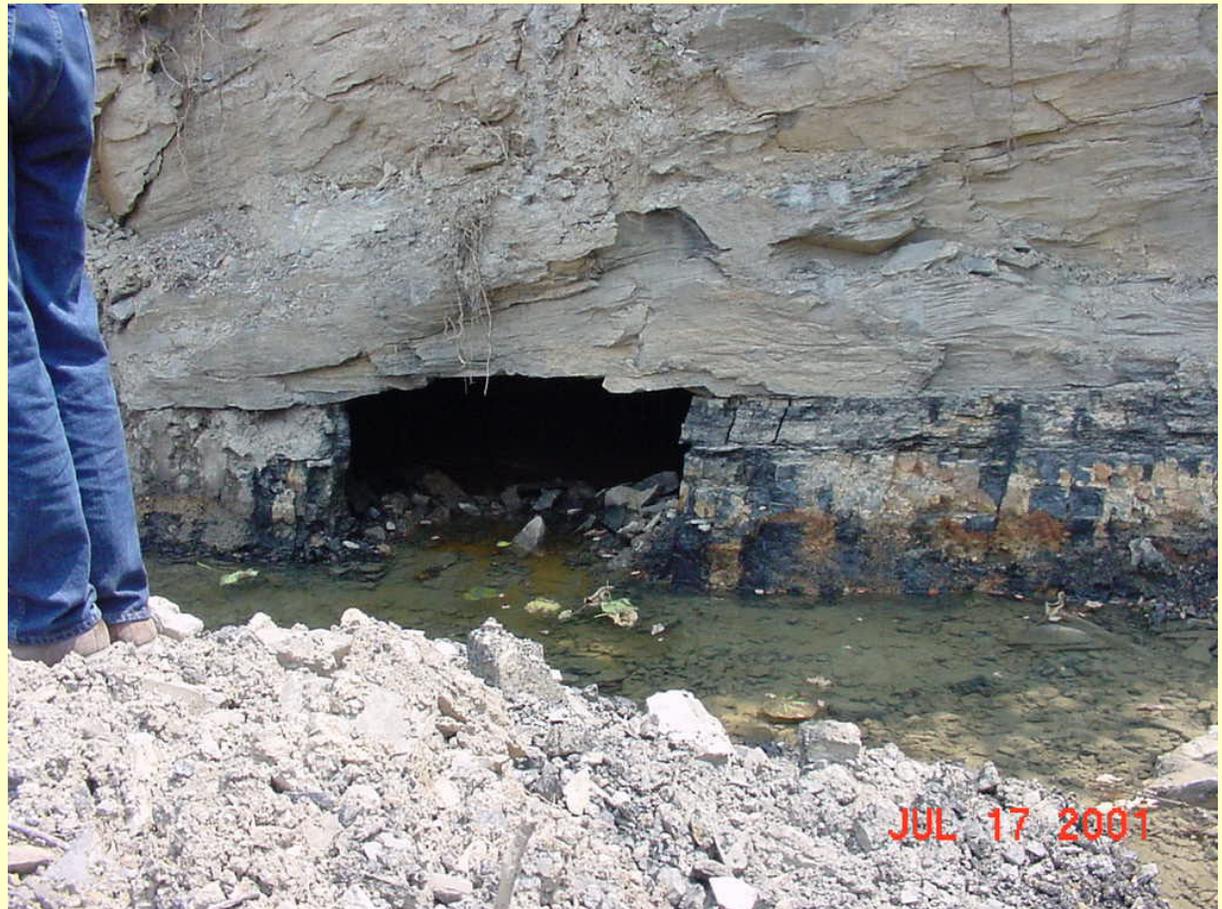
Outcrop Barrier Distances Taken From Mine Map Versus Drilling Results

Expected horizontal distance to mine workings from highwall, <u>based on mine map</u> , feet.	Actual horizontal distance to mine workings from highwall, <u>based on drilling</u> , feet.	Discrepancy , that is, workings were actually this much closer or farther from highwall than shown on mine map.
40	37.5	2.5 feet closer
122	92	30 feet closer
137	89	48 feet closer
27	67	40 feet farther
67	41	26 feet closer

Results of horizontal drilling shown on next slide.
