Monitoring of Pittsburgh seam mine water and hydrogeology in northern West Virginia (project HRC-5)

Final Report, Project HRC-5

West Virginia University
West Virginia Water Research Institute
Hydrogeology Research Center

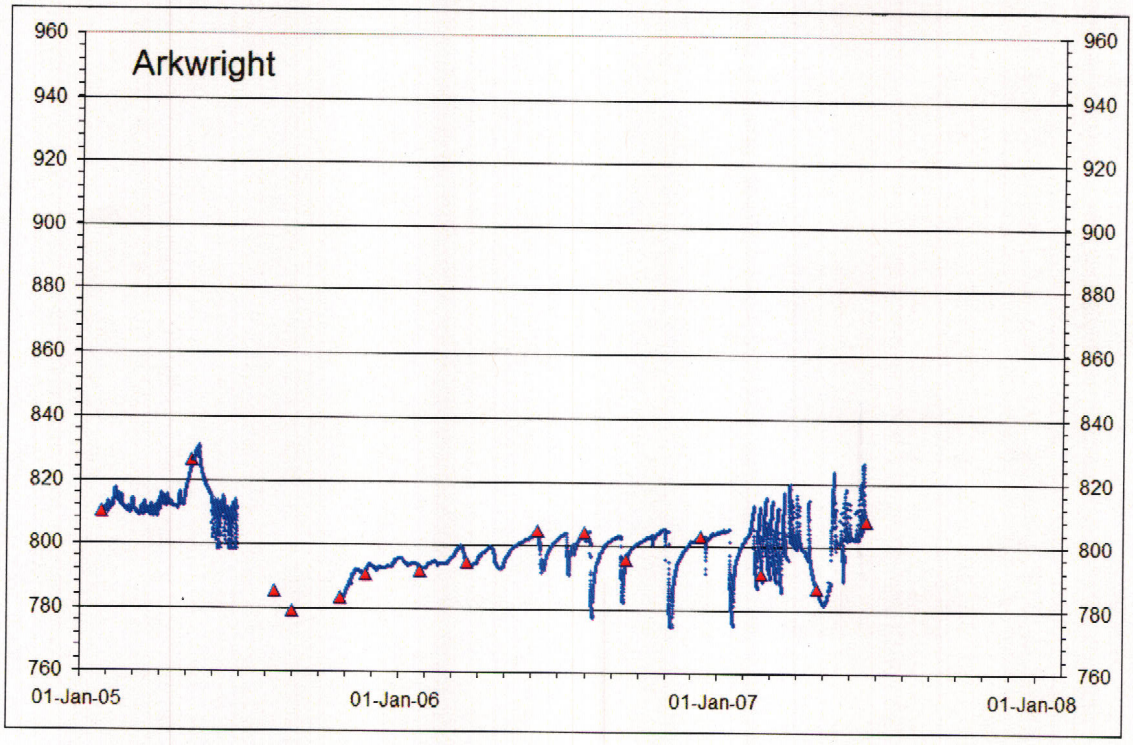
The pool elevation in Arkwright is maintained at approximately 800 ft AMSL by pumping to the treatment plant at Flaggy Meadows (Figure 1). The pumps are run from one to several days then shut off to prevent dewatering the pumps while the pool recovers. Recent addition of a transfer pump at Statler Shaft, which moves water from Osage into Arkwright has induced shorter recovery periods allowing more frequent pumping to the Flaggy Meadows treatment plant.

Figure 1: The water level at the Arkwright well is variable.

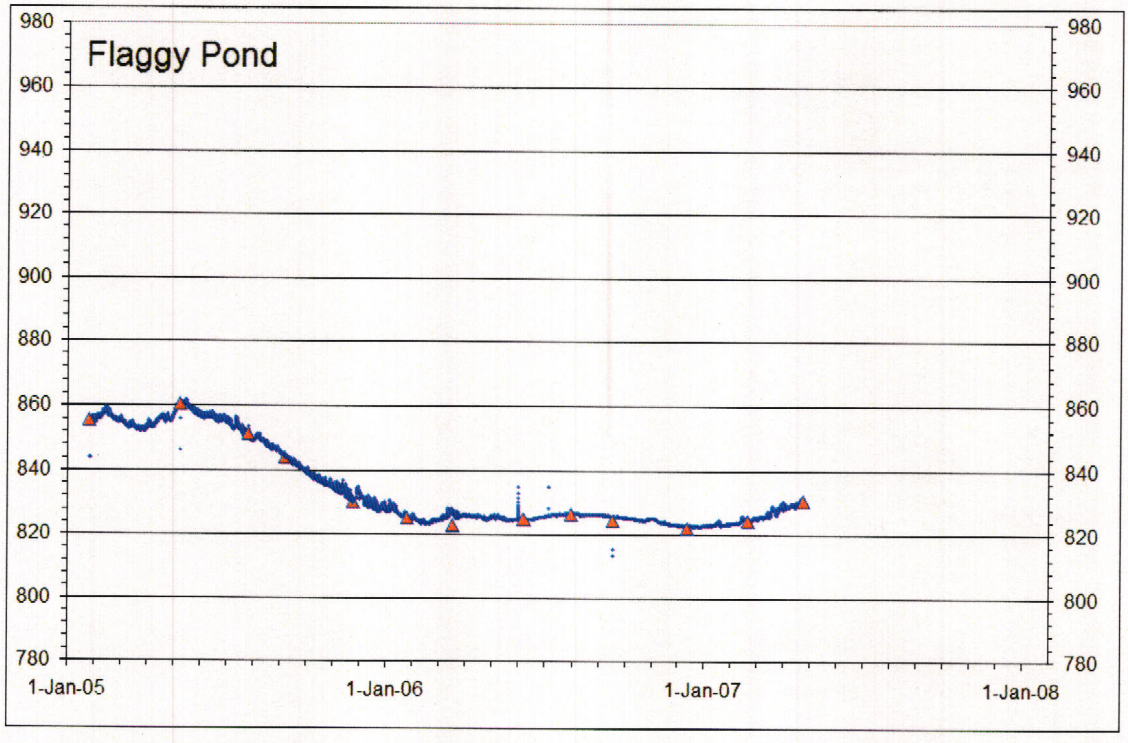
Sludge from the Flaggy Meadows treatment plant is injected into River Seam, which is monitored at Flaggy Pond. The pool elevation has dropped during the study period from a high of 860 ft to around 825 ft (Figure 2). As of the close of this project, the monitoring well is currently being used for sludge injection and the old sludge injection well is in the process of being outfitted for monitoring.

Figure 2: Head at Flaggy Pond decreased over the study period.

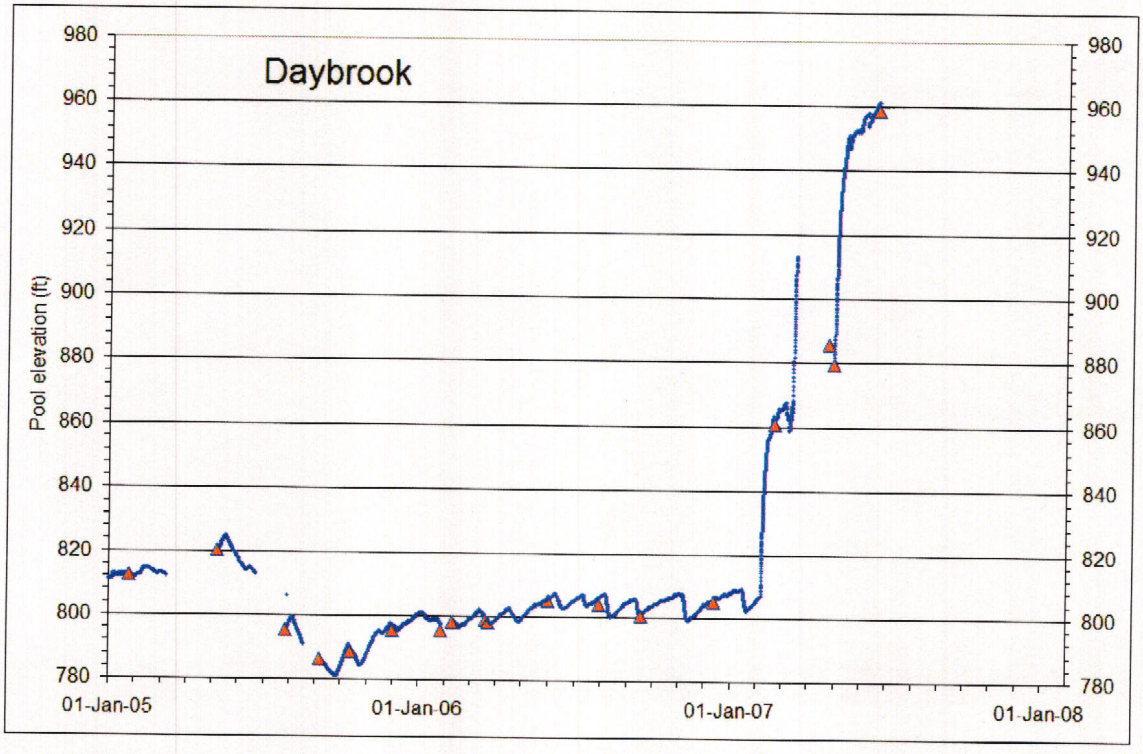
The pool elevation at Daybrook remained relatively constant prior to the installation of the transfer pump at Statler shaft, which moves mine water from Osage into Arkwright. The hydrograph for the early portion of the study period shows the effects of pumping at Flaggy Meadows and recovery periods (Figure 3). The later portion of the hydrograph shows the effects of transferring water from Osage into Arkwright.

Figure 3: Large head fluctuations were observed during the study period.

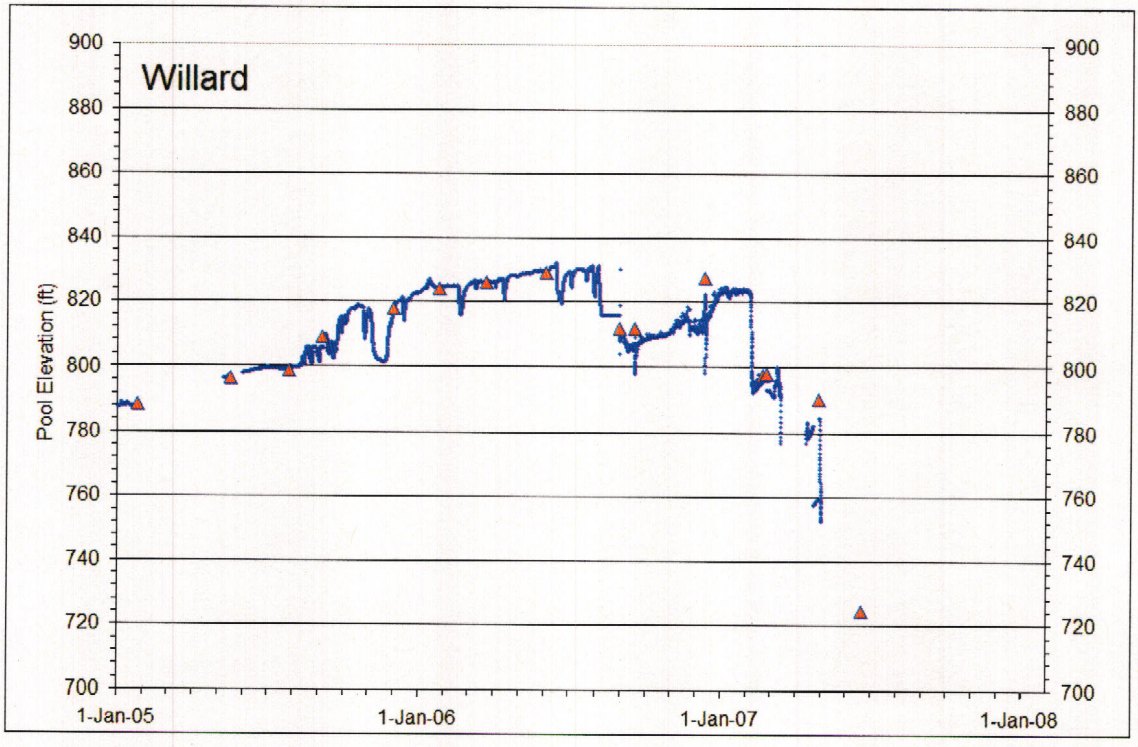
The pool in Osage is monitored at Willard (Figure 4). The hydrograph for Willard shows a general flooding trend for the early portion of the study period with intermittent pumping events and subsequent lowering of the pool following the installation of the transfer pump at Statler Shaft.

Figure 4: The water level in Osage decreased during the study.

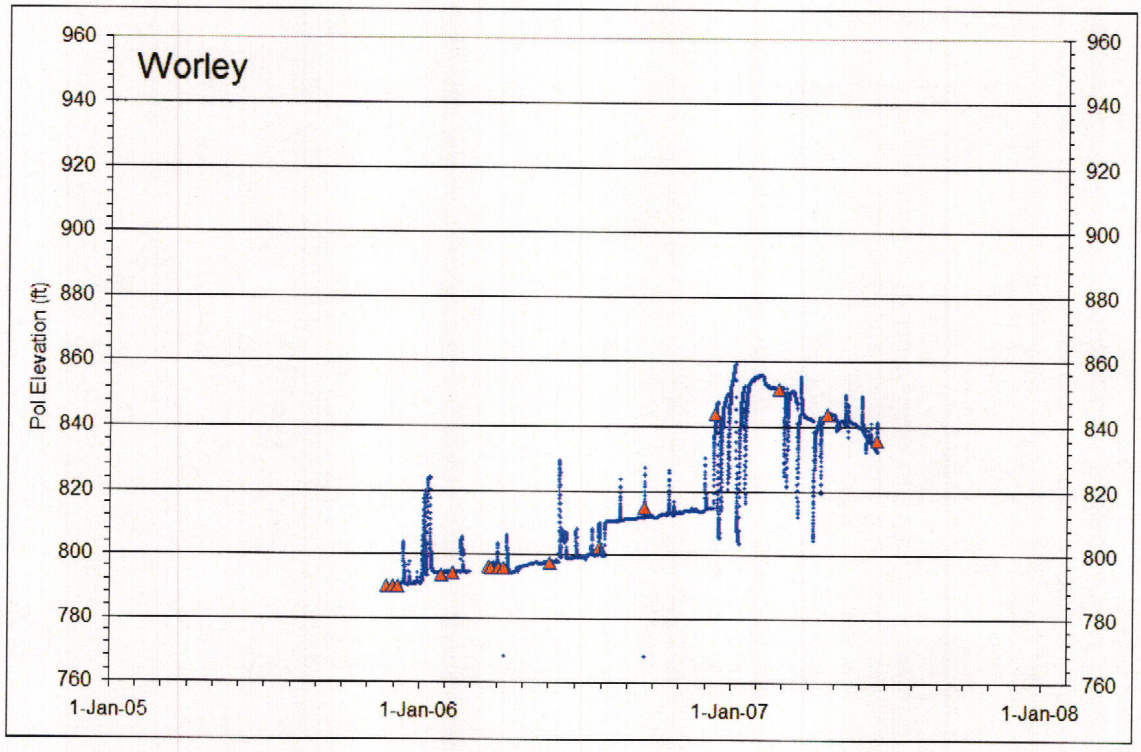
The pool in Pursglove is monitored at Worley (Figure 5), Fetty (Figure 6), and Fetty Core (Figure 7). The Fetty hydrograph shows the effects of transferring water from Humphrey into Pursglove. The effect is somewhat subdued at Worley, which lies at a greater distance from the injection borehole. The effect of pumping is also evident in the Fetty Core monitoring well, but is greatly subdued due to the effects of an internal mine barrier between the monitoring well and the injection borehole.

Figure 5: Large fluctuations in water level were observed at Worley.

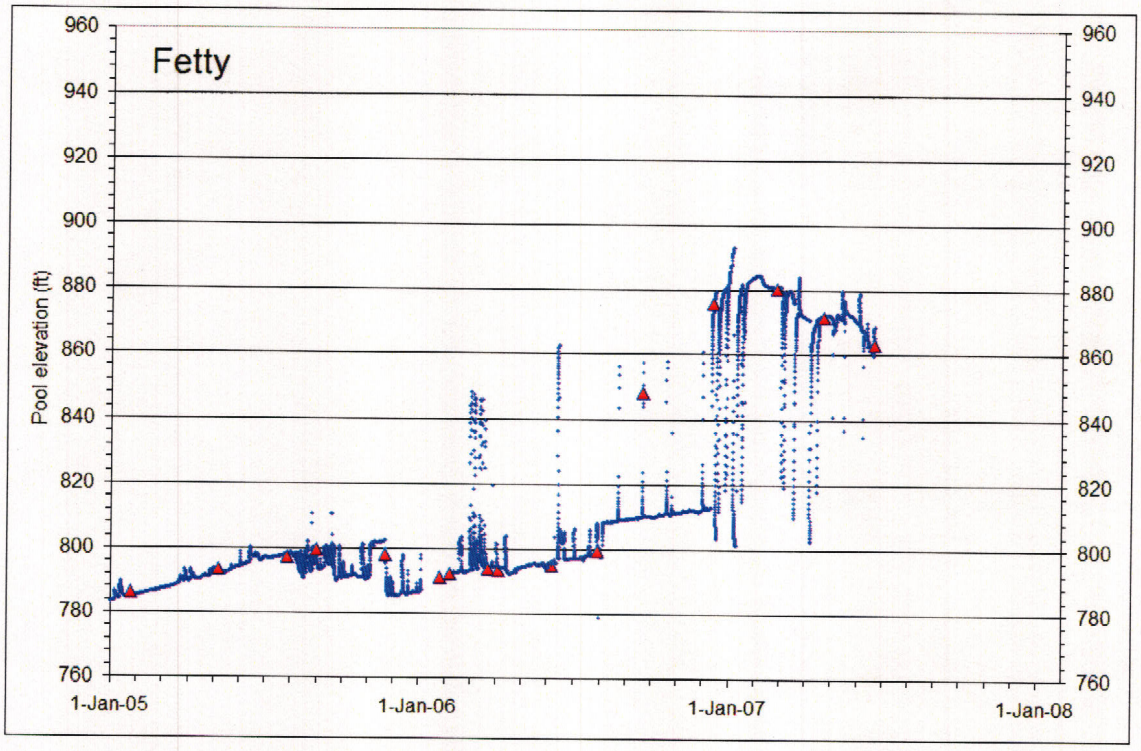
Figure 6: Large water level fluctuations were observed at Fetty.

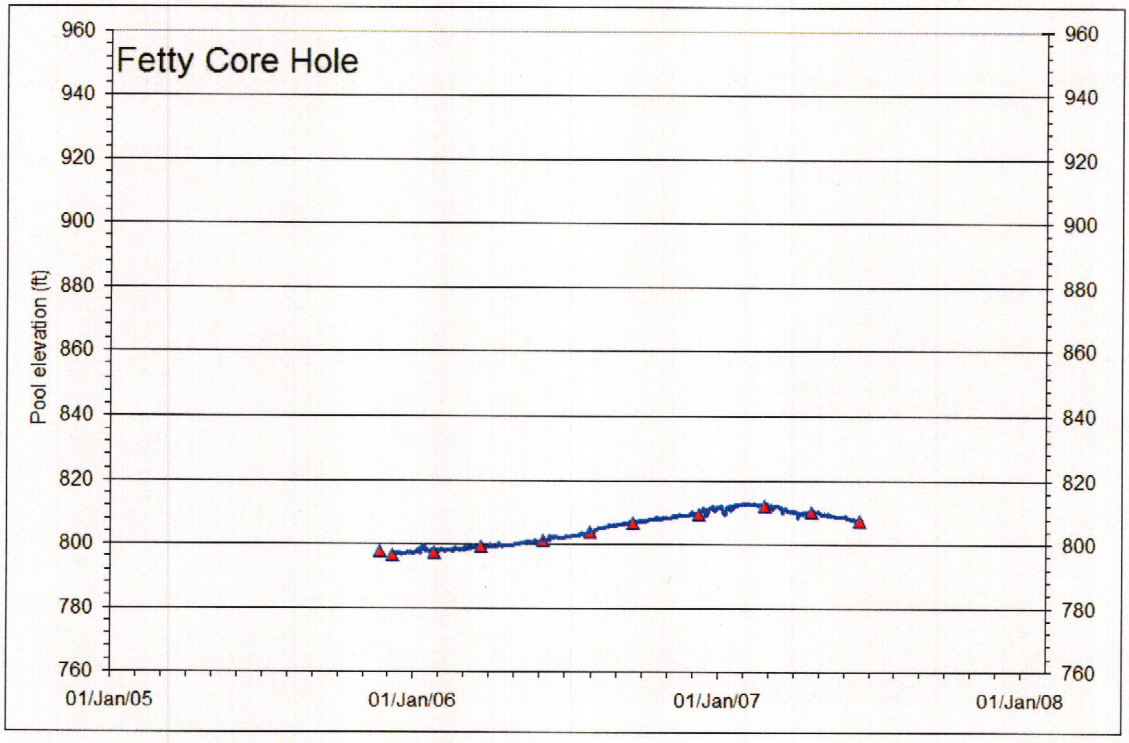
Figure 7: Small water level fluctuations were observed at Fetty Core.

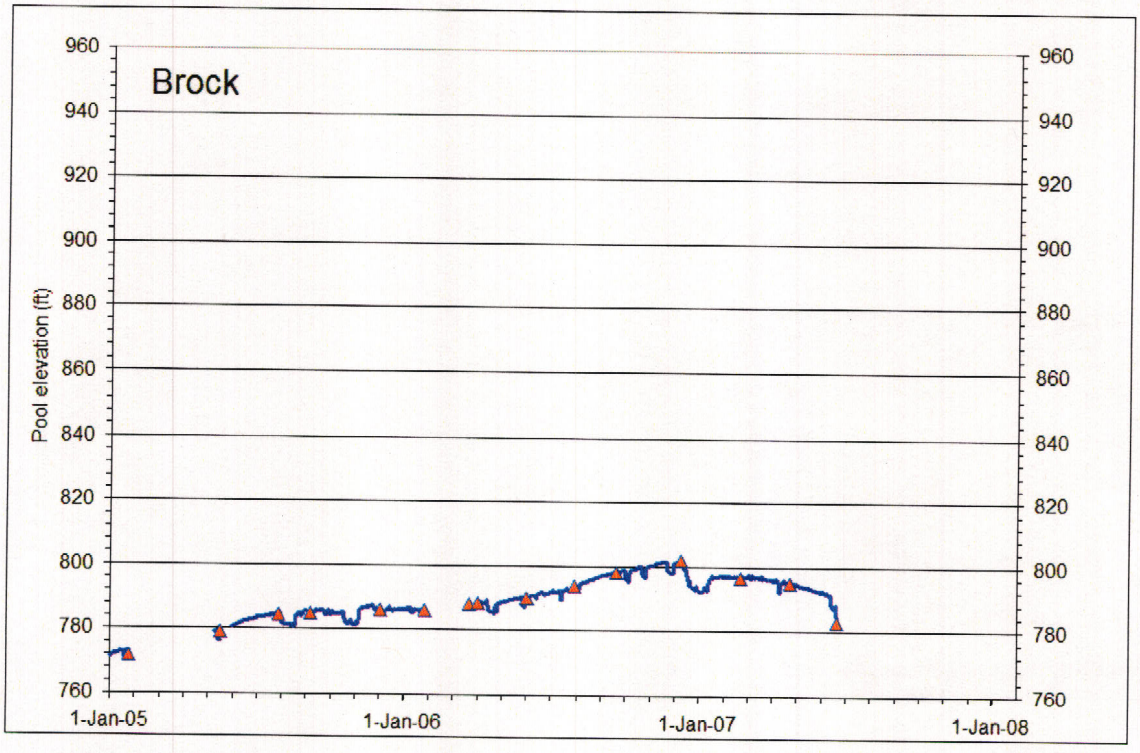
The pool in Humphrey is monitored at Brock and the hydrograph shows the effects of transferring water to Pursglove (Figure 8). The flooding trend has been reversed and the pool elevation is falling.

Figure 8: Small water level fluctuations were observed in Humphrey.

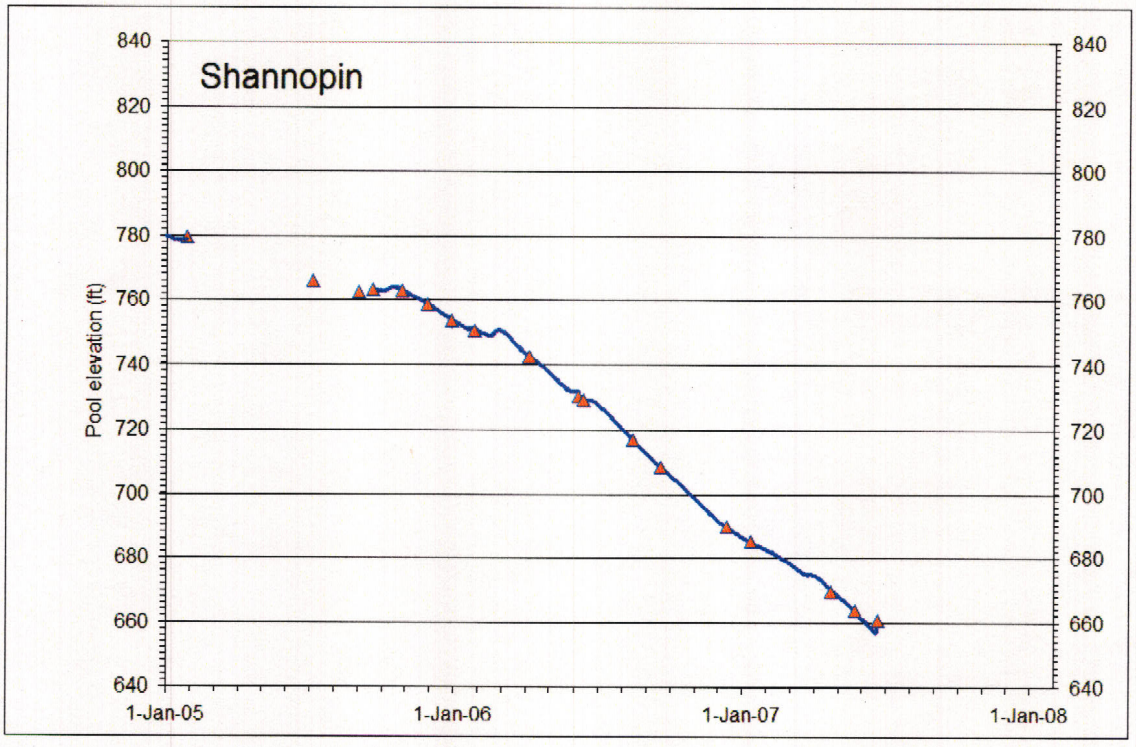
The pool elevation in Shannopin is recorded at the Shannopin monitoring well (Figure 9). The water level in Shannopin has been steadily declining during the study period due to pumping at Steele Shaft.

Figure 9: The water level in Shannopin is decreasing.

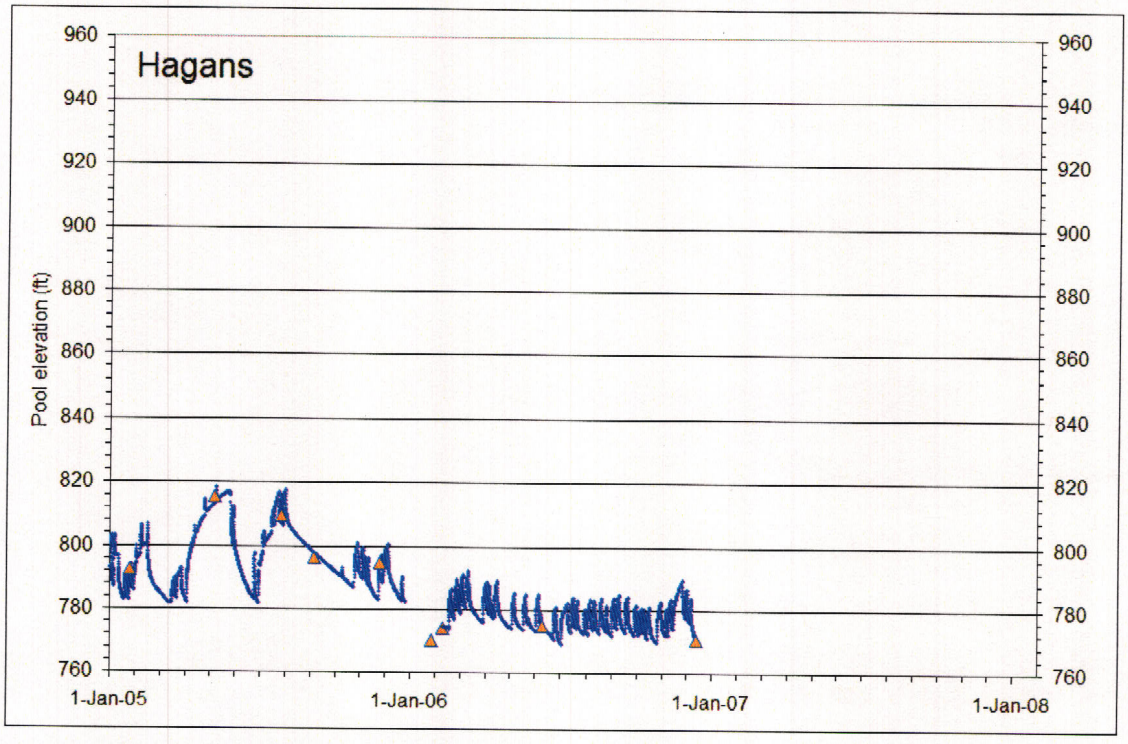
The pool elevation in Jordan is maintained by pumping at Hagans Shaft (Figure 10) to the Dogwood Lakes treatment plant. The water level in Jordan fluctuates 15 to 20' around 790' AMSL.

Figure 10: The water level at Hagans dropped during the study period.

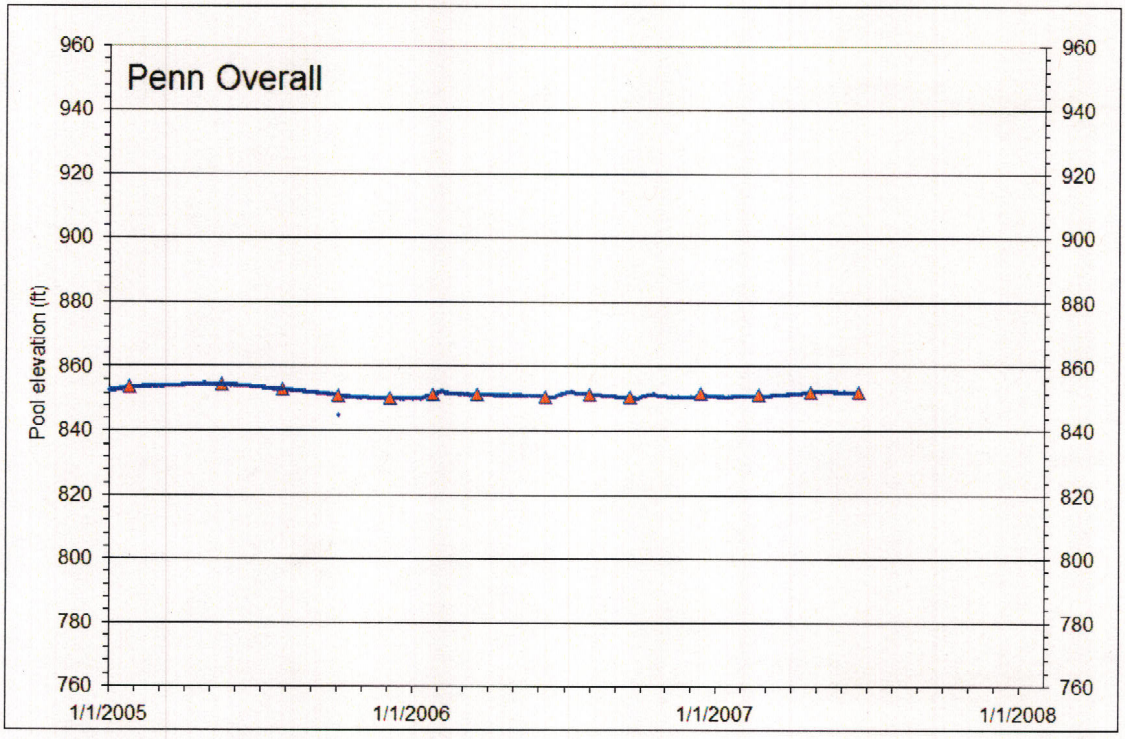
The Fairmont pool is monitored at Penn Overall (Figure 11), Carberry (Figure 12), and Barrackville (Figure 13). The water levels at Penn Overall and Carberry fluctuated around 850 ft AMSL during the study period while the Barrackville water-level elevation fluctuates around 835 ft AMSL.

Figure 11: The water level at Penn Overall remained relatively constant.

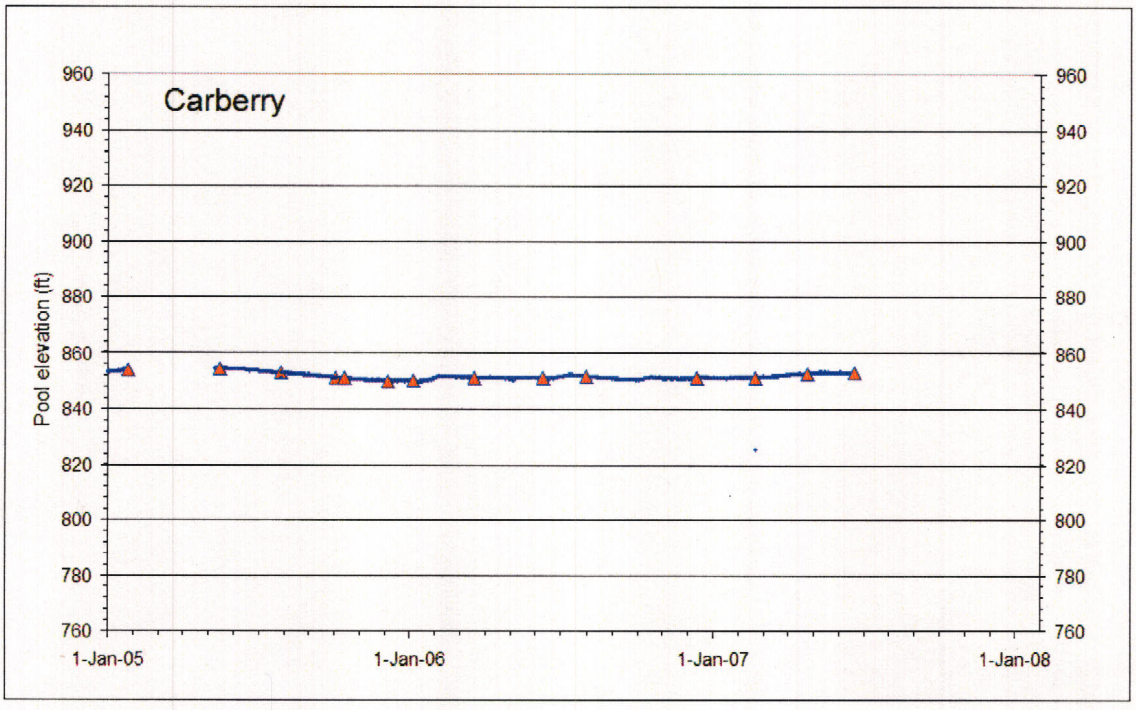
Figure 12: The Carberry hydrograph shows only slight variation.

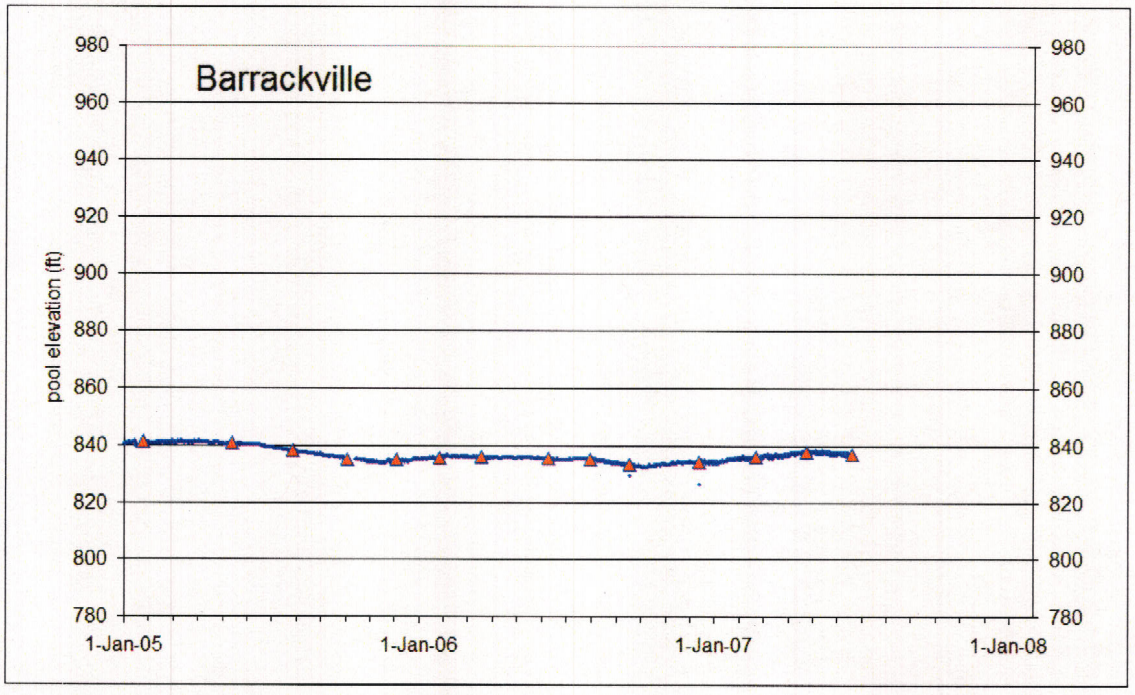
Figure 13: Barrackville shows seasonal variation.

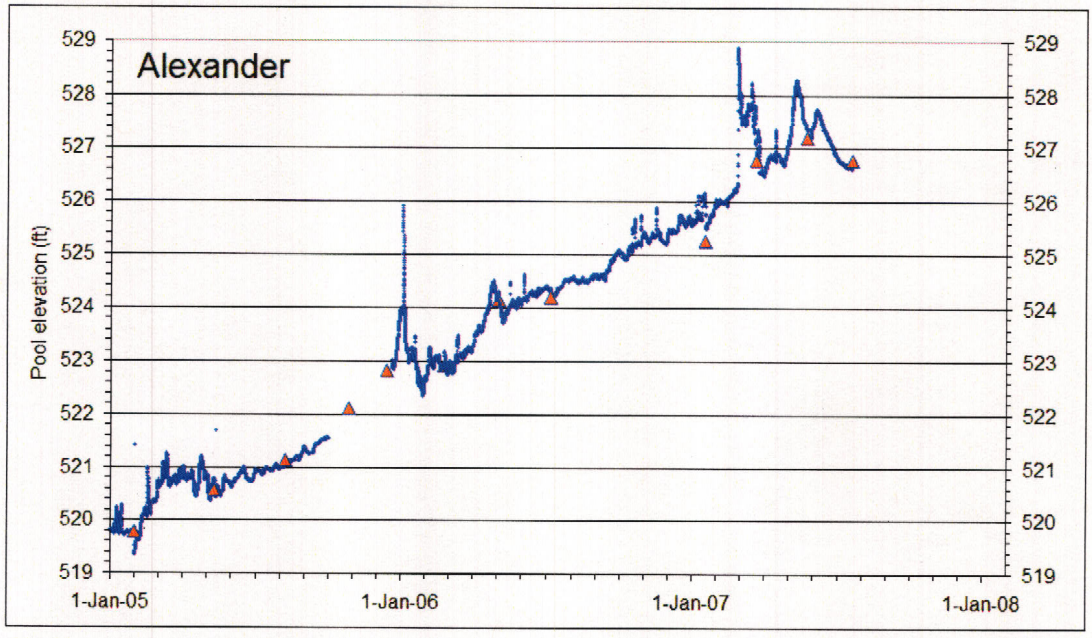
Interpretation of water levels in the Northern Panhandle shows that Alexander Mine (Figure 14) continues to flood at a rate of approximately three feet per year while the hydrographs for Glen Dale (Figure 15) and Valley Camp #3 (Figure 16) indicate that these two pools have remained constant. Other pool elevations in the panhandle were estimated using the elevation of discharges combined with the structural contours for the Pittsburgh coal. Within each mine containing a discharge, everything down dip from the discharge was assumed flooded. The interpreted extent of flooding in the Northern Panhandle is shown on Plate 2.

Figure 14: Alexander continues to flood at a rate of approximately three feet per year.

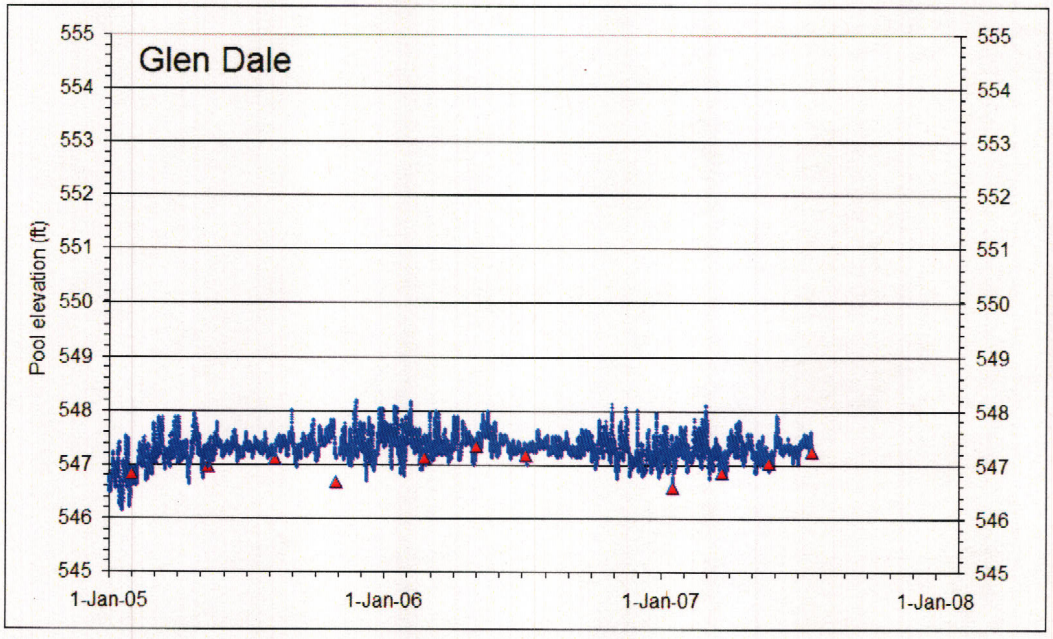
Figure 15: The pool elevation in Glen Dale remained stable during the study period.

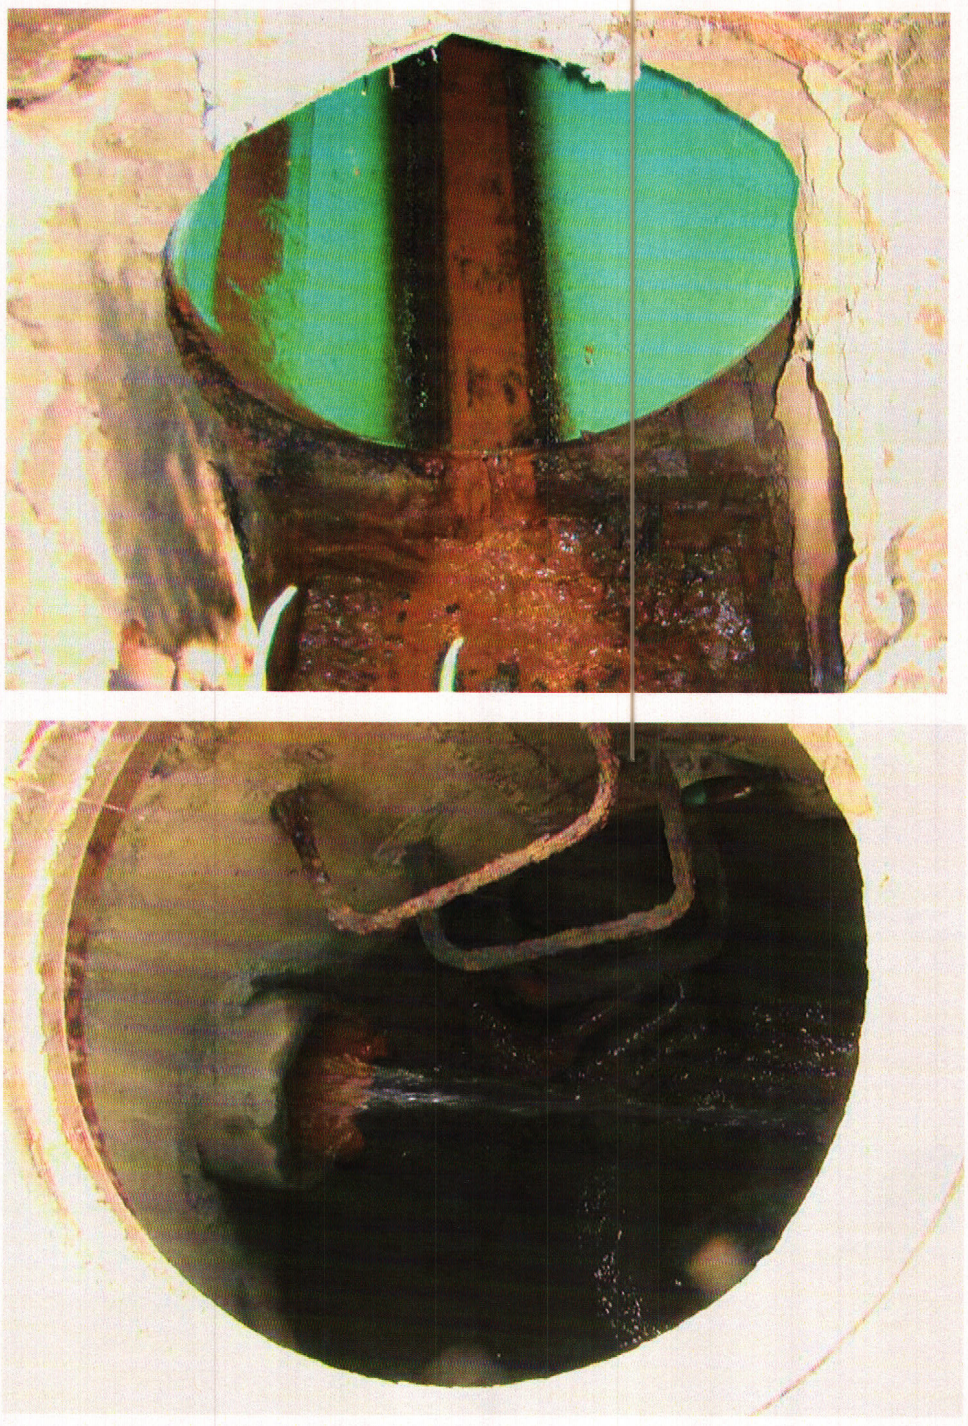
AMD discharge names and locations are summarized in Table 1. The Ohio River sites are numbered in the order visited while the other surface water and sanitary sewer locations are named by PPCD based on their street address. All of the discharges were observed in late spring and early summer during low flow conditions. Flows varied from 1 or 2 gpm to approximately 25 gpm (Figure 17), although there is significant staining at many of the sites indicating previous large flows (Figure 18).

Figure 17: Flow rates varied between 1 to 2 gpm (above) and approximately 25 gpm (below).

Figure 18: Wet-weather high flows are indicated by staining.

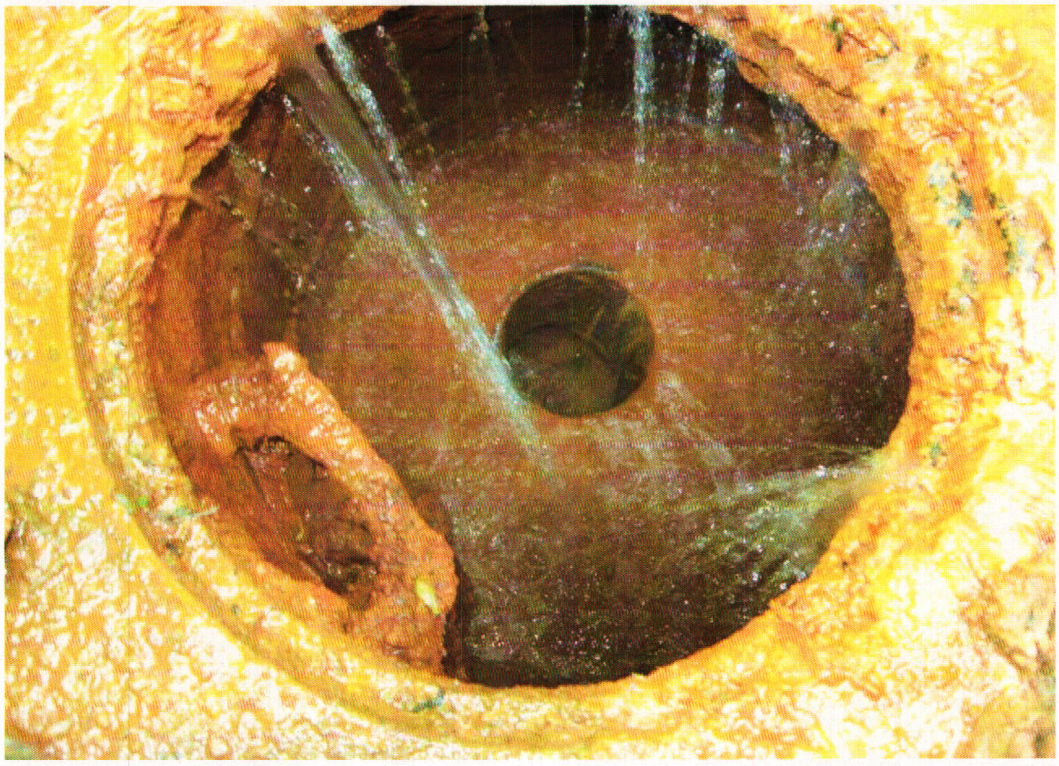
AMD sludge tends to accumulate in both the surface water (Figure 19) and sanitary sewer (Figure 20) systems requiring frequent maintenance to keep the system

Figure 19: AMD sludge is periodically removed from this catch basin on Carmel Rd.

Figure 20: AMD sludge may plug sewer pipes causing overflow.

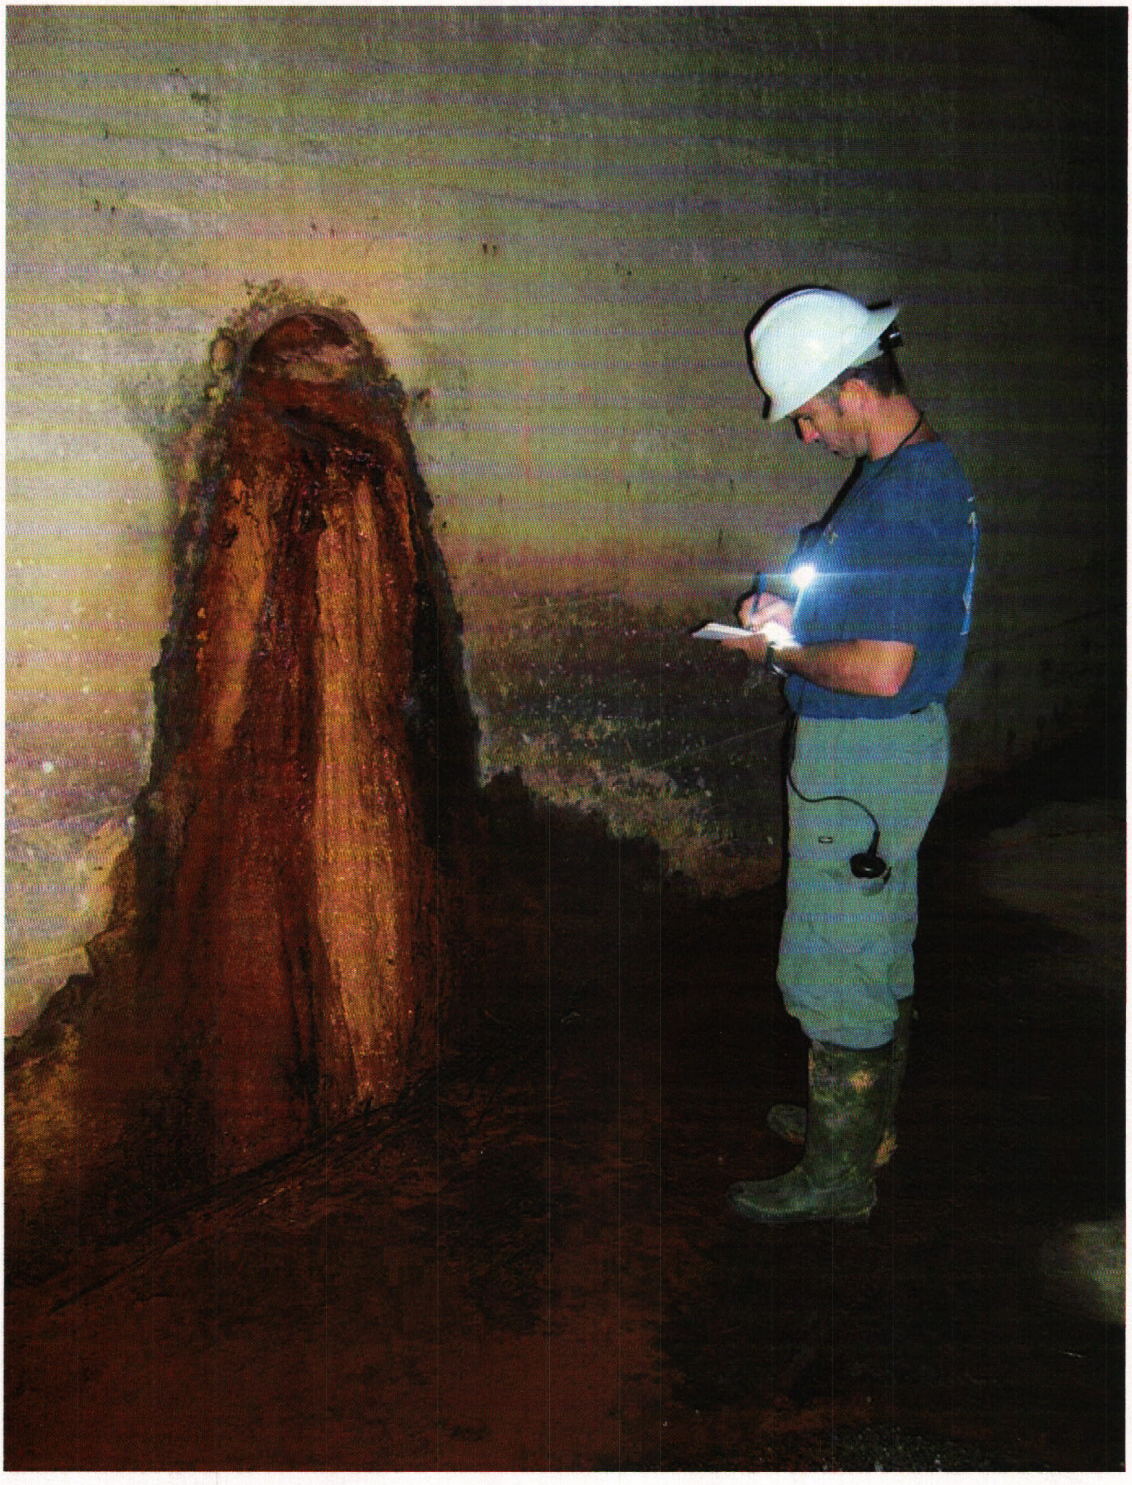
Figure 21: AMD sludge partially fills a 12" culvert in the 29th St. tunnel.

Figure 22: A 12" culvert in the 29th St. tunnel is nearly plugged with AMD sludge.

operating. A large number of the drains entering the 29th St. culvert were either partially or fully filled with sludge (Figures 21 and 22).
