BLASTING and MSHA?

**Thomas E. Lobb
U.S. Department of Labor,
MSHA
Technical Support, A&CC**

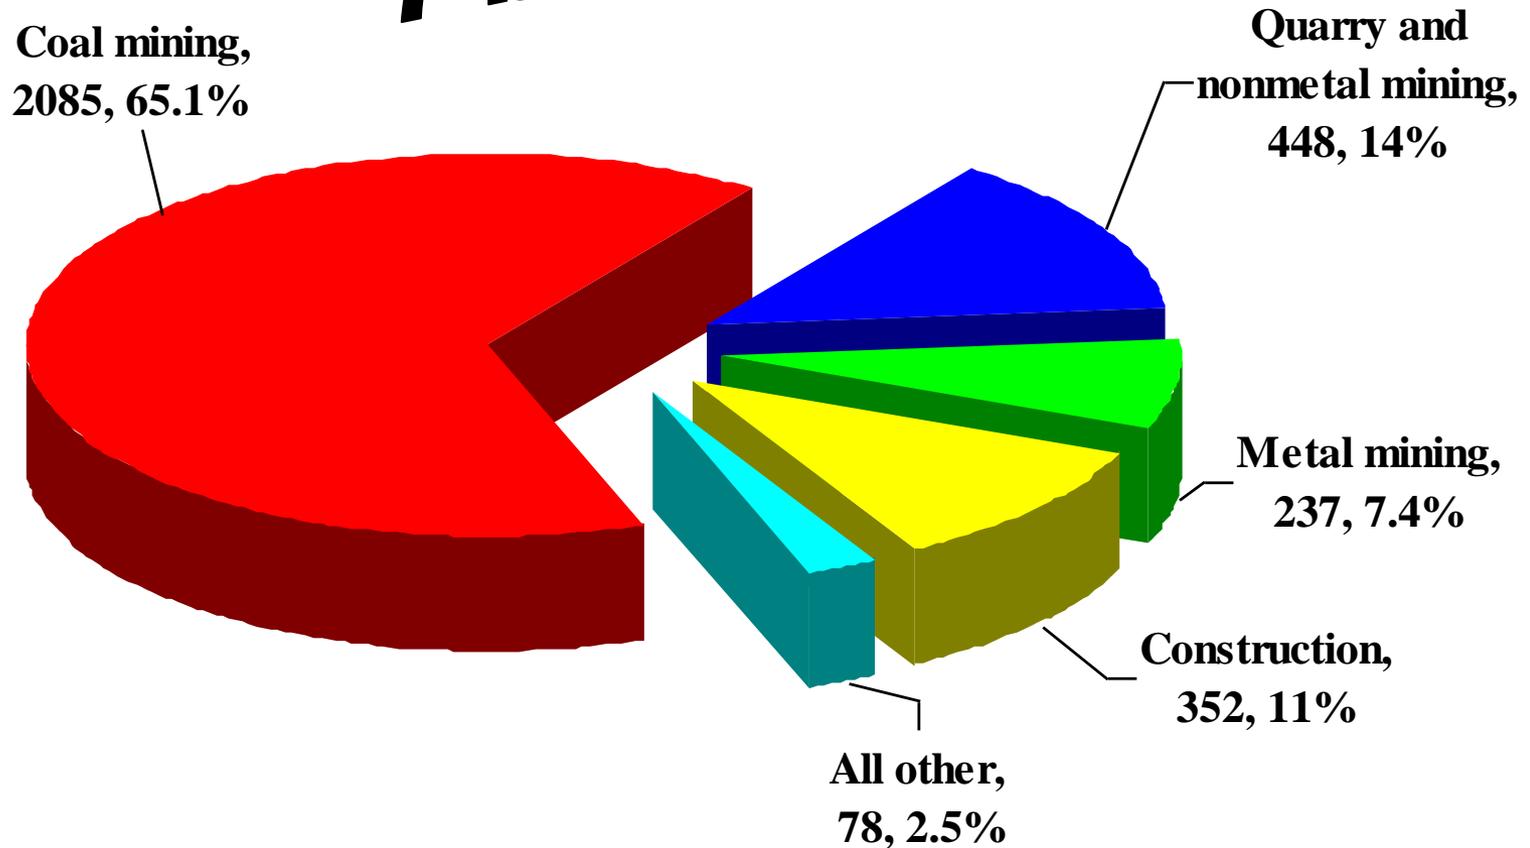
Figure 1 - Explosives & Blasting Agent Consumption in 2005
(thousand metric tons)

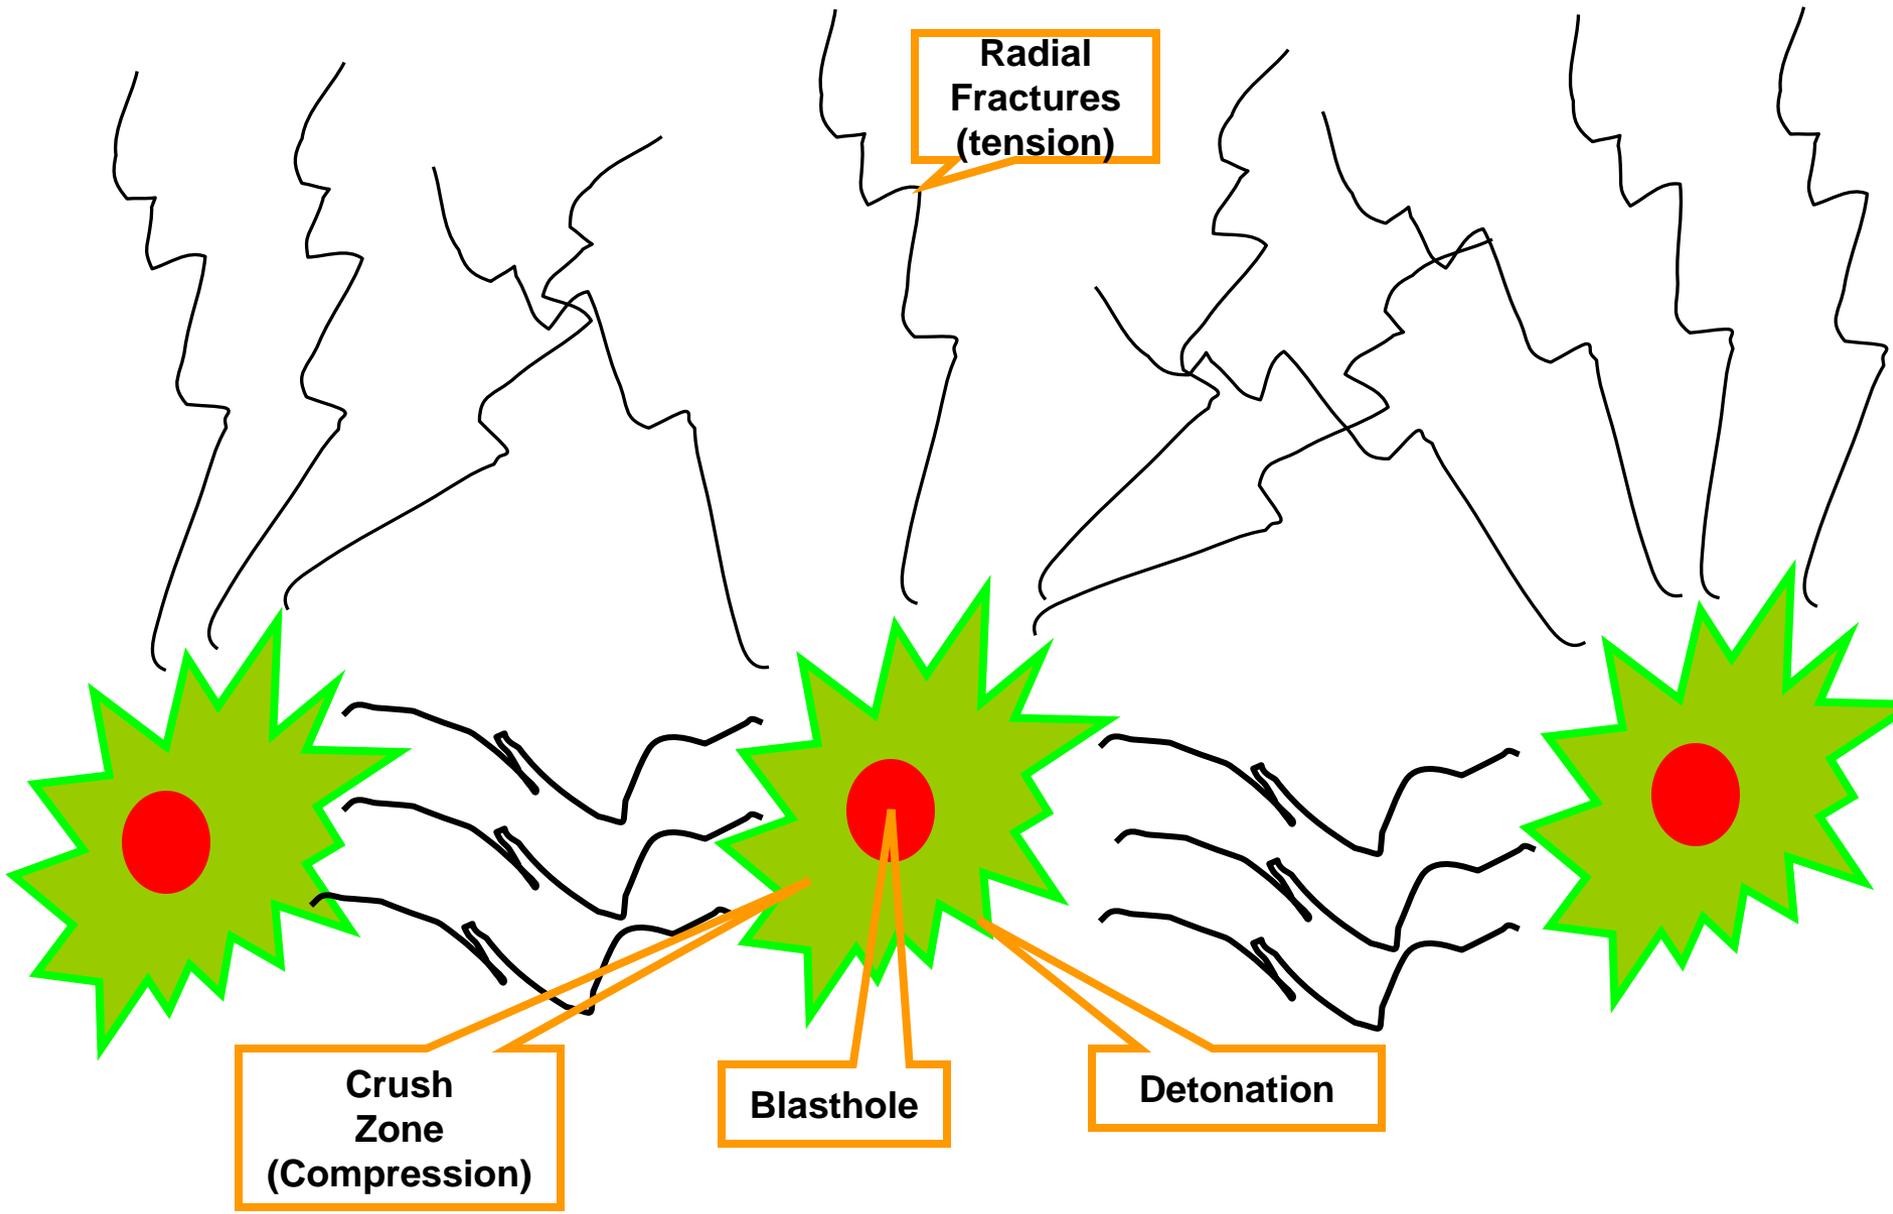
Radial Fractures (tension)

Crush Zone (Compression)

Blasthole

Detonation

As the number of rows increase, rock movement tends toward the vertical due to the low velocity of broken rock. Successively reducing relief toward quarry face.

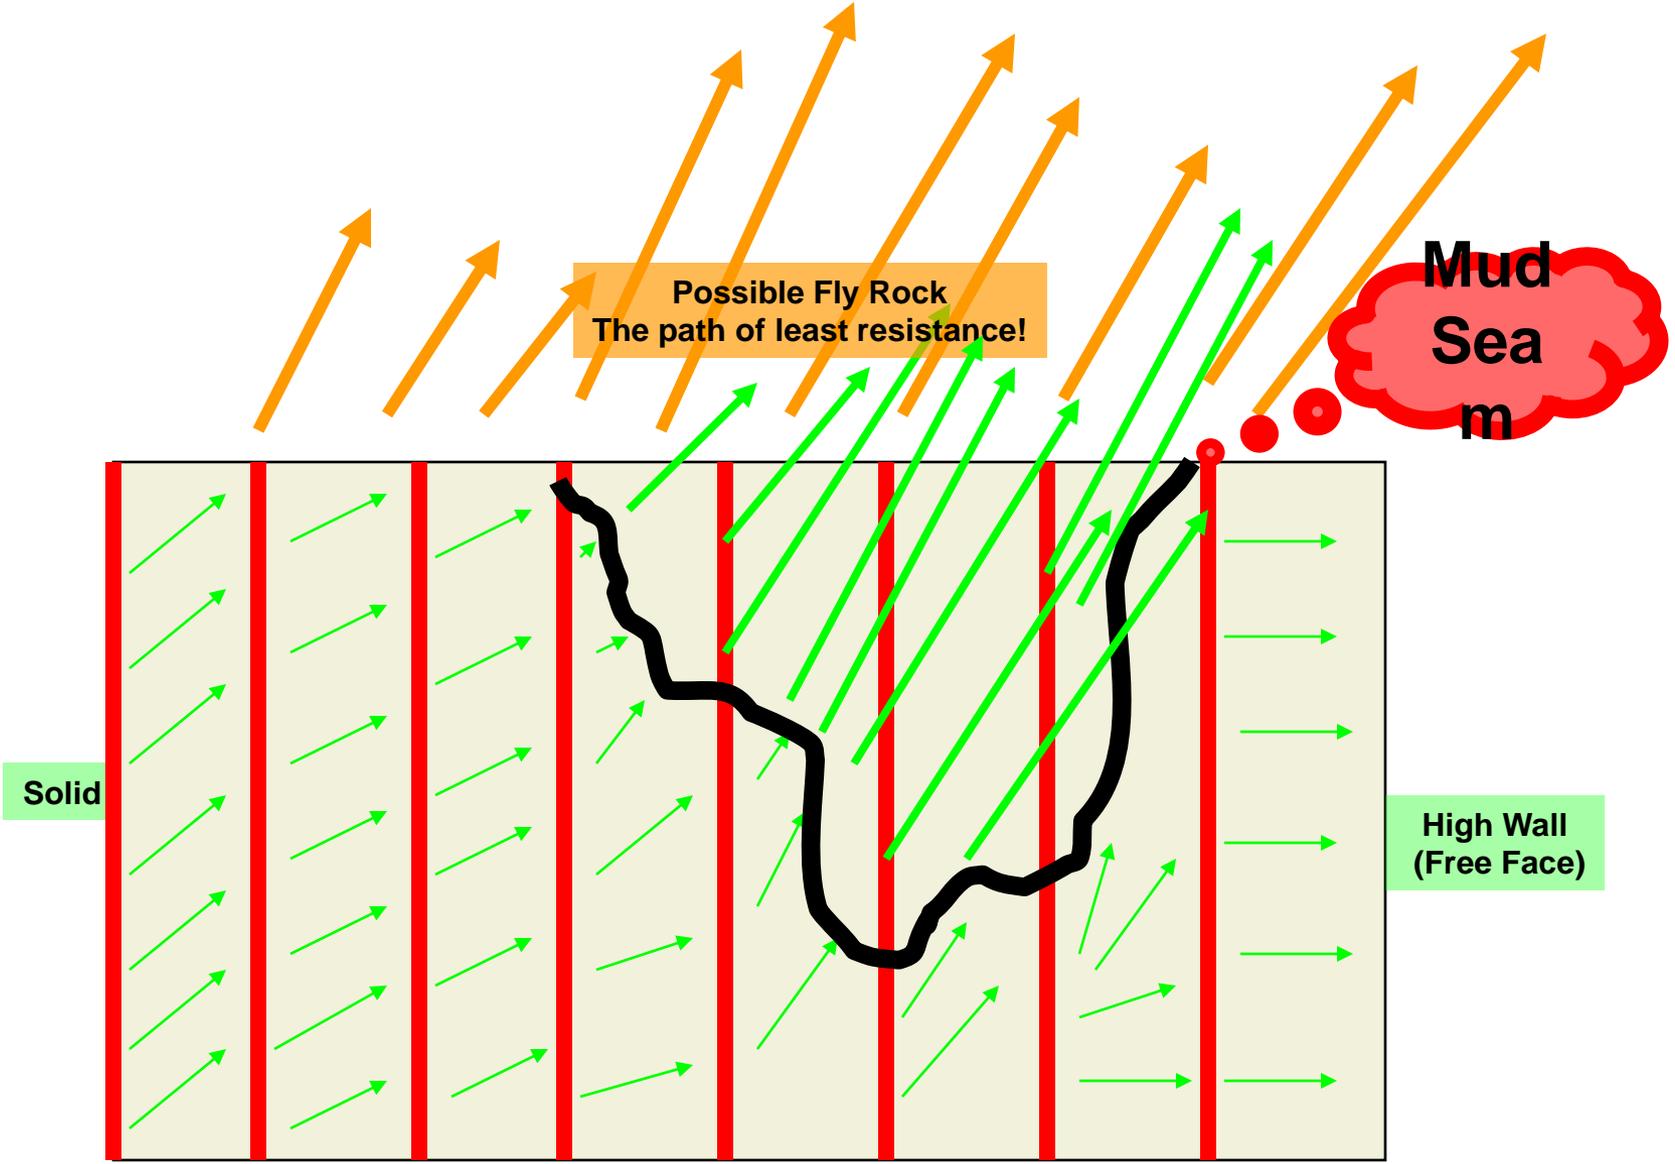
Solid

Possible Fly Rock
The path of least resistance!

Mud
Sea
m

High Wall
(Free Face)

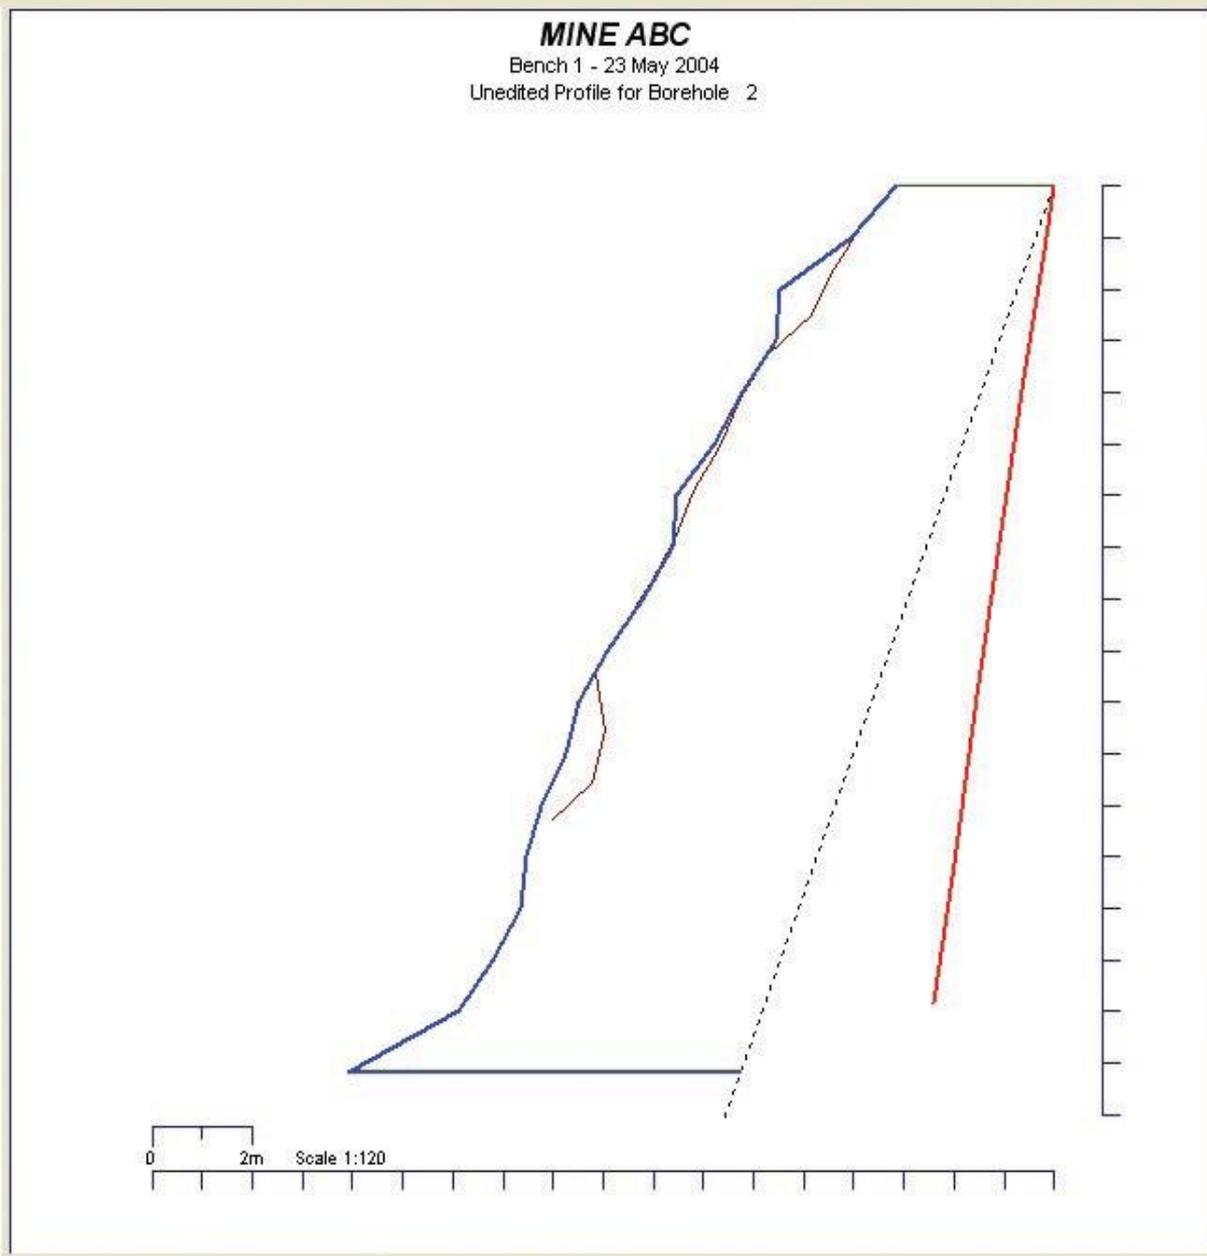
Burden Data:

Borehole Depth	Burden @ Depth	True Offset	Separati to Previ Hole
1.0	Undefined	0.0	3.0
2.0	3.7	0.4	3.0
3.0	4.3	0.6	3.0
4.0	4.8	0.8	3.0
5.0	5.2	1.0	3.0
6.0	5.6	1.2	2.9
7.0	6.0	1.4	2.9
8.0	6.3	1.6	3.0
9.0	6.6	1.8	3.0
10.0	6.9	2.0	3.0
11.0	7.3	2.2	3.0
12.0	7.8	2.4	3.1
13.0	8.0	2.6	3.1
14.0	7.7	2.8	3.2
15.0	8.3	3.0	3.2
16.0	Undefined	0.0	3.3
17.0	Undefined	0.0	4.0
18.0	Undefined	0.0	3.0
19.0	Undefined	0.0	3.0
19.3	Undefined	0.0	3.0

Profile Data: (FlexT Data)

Diameter	115.00 mm
Hole Angle	Varies
Hole Depth	16.0 m
Stemming	3.0 m
Back Fill:	0.0 m
SubDrill	1.0 m
Area	114.4 m ²
Volume	365 m ³
Min Burden	4.26 m
@ Depth	3.0 m
Max Burden	8.34 m
@ Depth	15.0 m
Ave Burden	6.53 m
Exp Mass:	0.0 kg
Nominal Powder Factor:	
	0.000 kg/m ³
	0.000 kg/ton

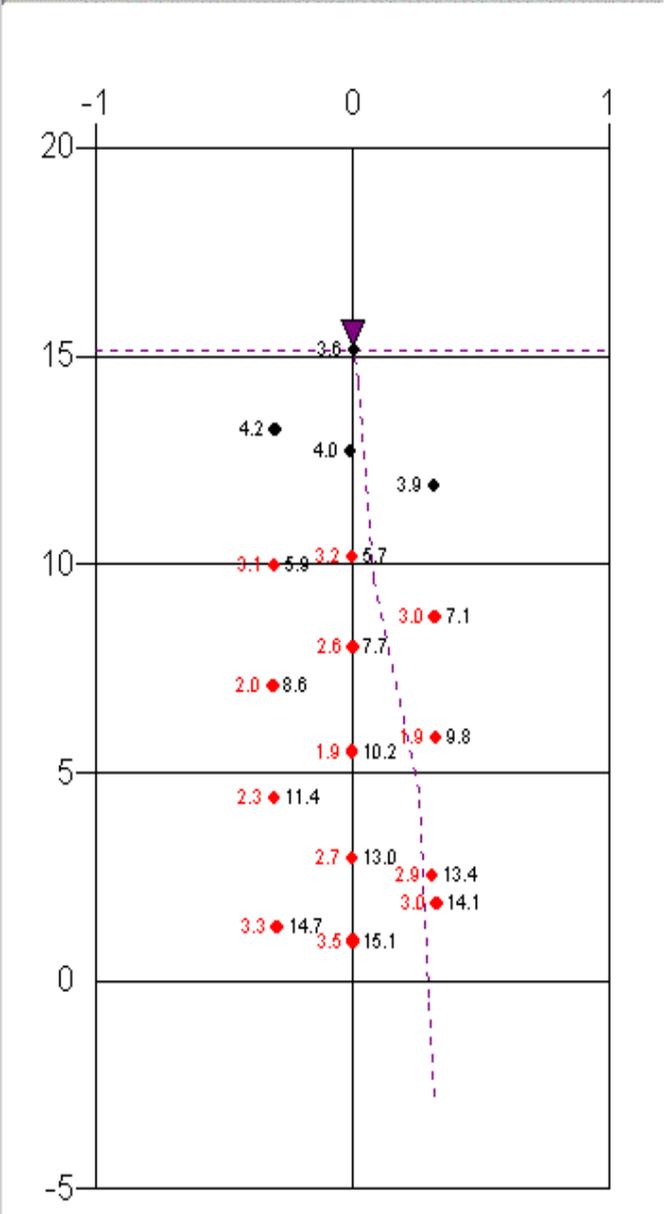
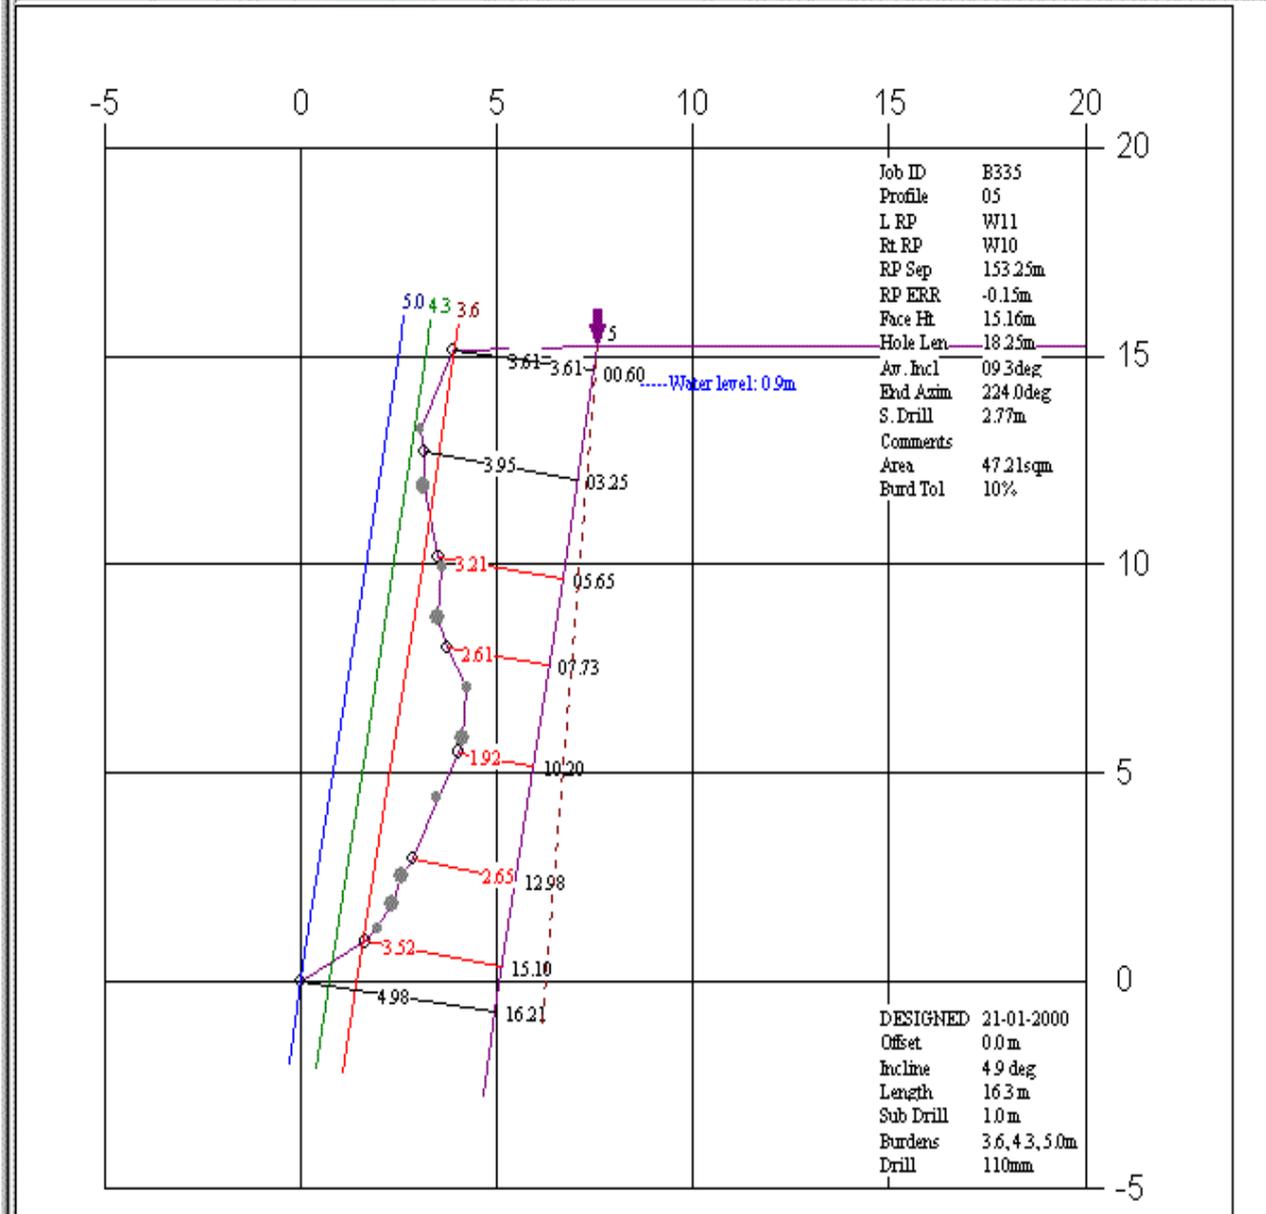
Face and Hole Survey for Hole 5 [B335 210100]

Face View Hole 5 [B335]

Job ID	B335
Profile	05
L RP	W11
Rt RP	W10
RP Sep	153.25m
RP ERR	-0.15m
Face Ht	15.16m
Hole Len	18.25m
Av. Incl	09.3deg
End Azim	224.0deg
S. Drill	2.77m
Comments	
Area	47.21sqm
Burd Tol	10%

DESIGNED	21-01-2000
Offset	0.0m
Incline	4.9 deg
Length	16.3 m
Sub Drill	1.0m
Burdens	3.6, 4.3, 5.0m
Drill	110mm

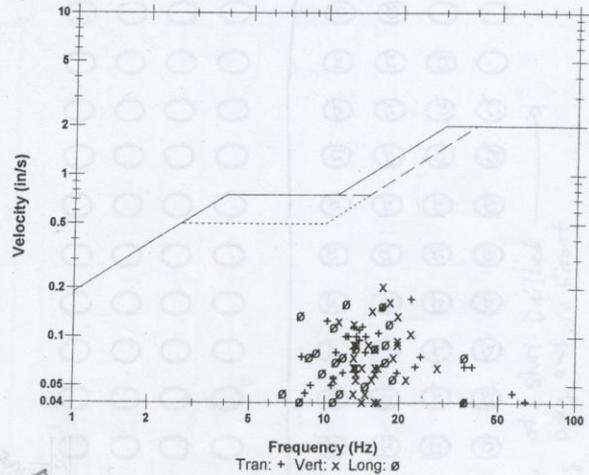
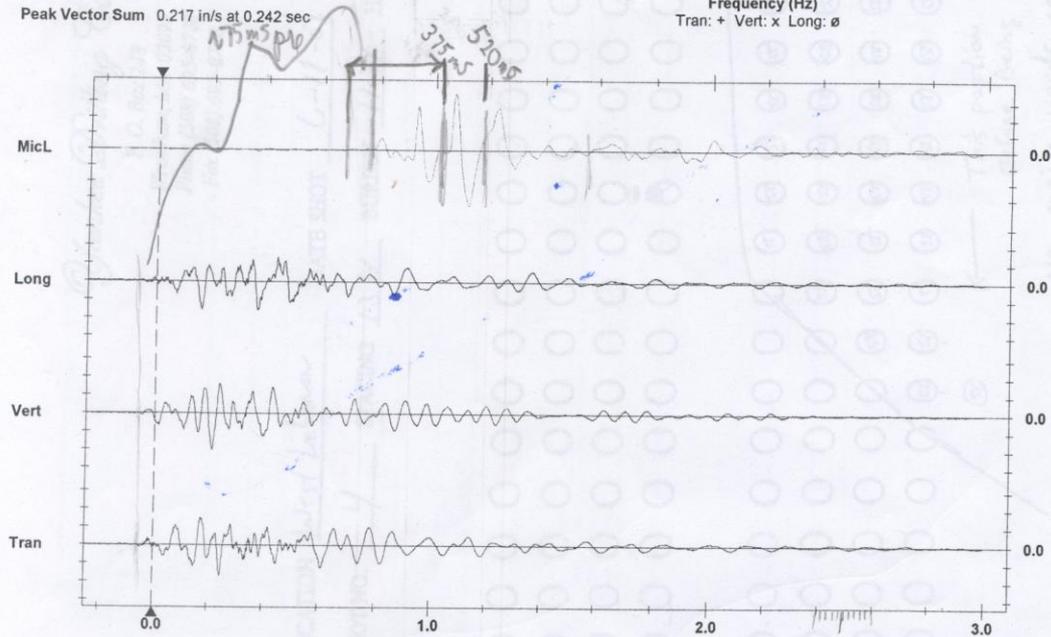
Event Report

Date/Time Vert at 12:05:23 June 11, 2007
 Trigger Source Geo: 0.0400 in/s
 Range Geo: 10.00 in/s
 Record Time 3.0 sec at 1024 sps

Serial Number BA6949 V 8.12-8.0 BlastMate III
 Battery Level 6.3 Volts
 Calibration March 15, 2007 by InstanTel Inc.
 File Name H949BPMP.KZ0

Microphone Linear Weighting
 PSPL 135.7 dB(L) at 1.070 sec
 ZC Freq 12 Hz
 Channel Test Passed (Freq = 19.3 Hz Amp = 574 mv)

Tran	Vert	Long	
PPV	0.170	0.205	0.160	in/s
ZC Freq	22	17	12	Hz
Time (Rel. to Trig)	0.246	0.212	0.371	sec
Peak Acceleration	0.0795	0.0795	0.0795	g
Peak Displacement	0.00163	0.00187	0.00201	in
Sensorcheck	Passed	Passed	Passed

Peak Vector Sum 0.217 in/s at 0.242 sec

Time Scale: 0.20 sec/div Amplitude Scale: Geo: 0.100 in/s/div Mic: 0.00500 psi(L)/div
 Trigger =

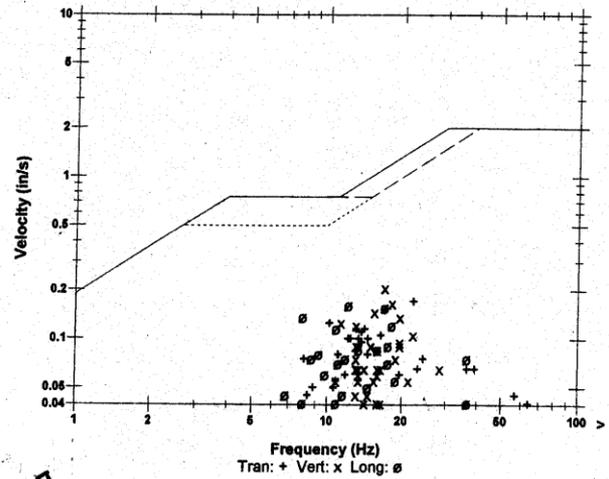
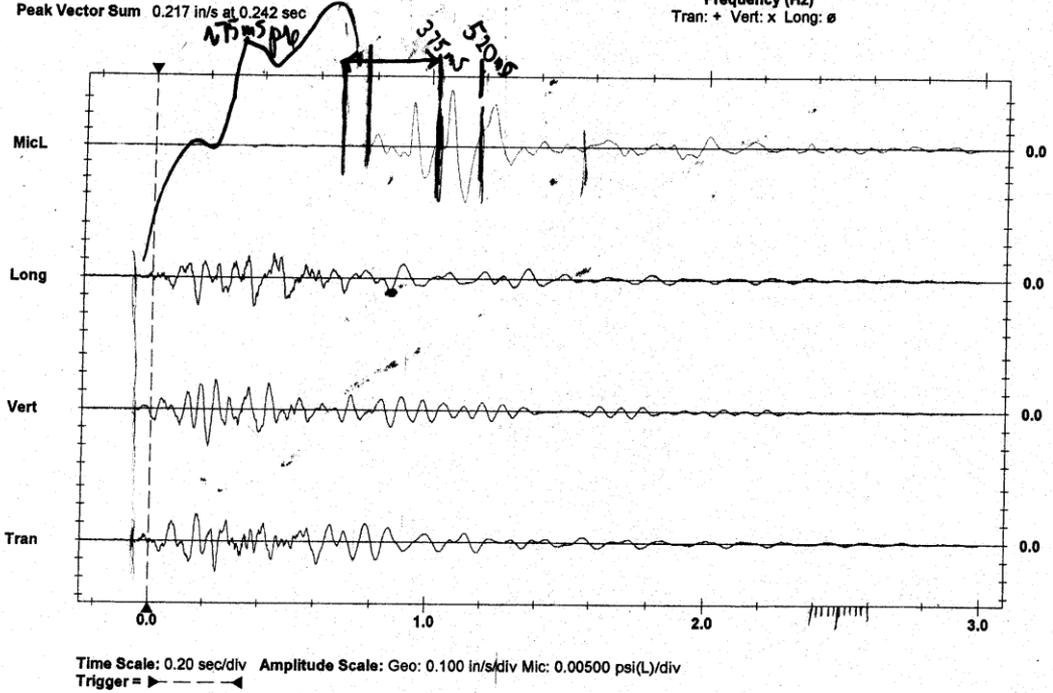
Event Report

Date/Time Vert at 12:05:23 June 11, 2007
 Trigger Source Geo: 0.0400 in/s
 Range Geo: 10.00 in/s
 Record Time 3.0 sec at 1024 sps

Serial Number BA6949 V 8.12-8.0 BlastMate III
 Battery Level 6.3 Volts
 Calibration March 15, 2007 by InstanTel Inc.
 File Name H949BPMP.KZO

Microphone Linear Weighting
 PSPL 135.7 dB(L) at 1.070 sec
 ZC Freq 12 Hz
 Channel Test Passed (Freq = 19.3 Hz Amp = 574 mv)

Tran	Vert	Long	
PPV	0.170	0.205	0.180	in/s
ZC Freq	22	17	12	Hz
Time (Rel. to Trig)	0.246	0.212	0.371	sec
Peak Acceleration	0.0795	0.0795	0.0795	g
Peak Displacement	0.00163	0.00187	0.00201	in
Sensorcheck	Passed	Passed	Passed

Peak Vector Sum 0.217 in/s at 0.242 sec

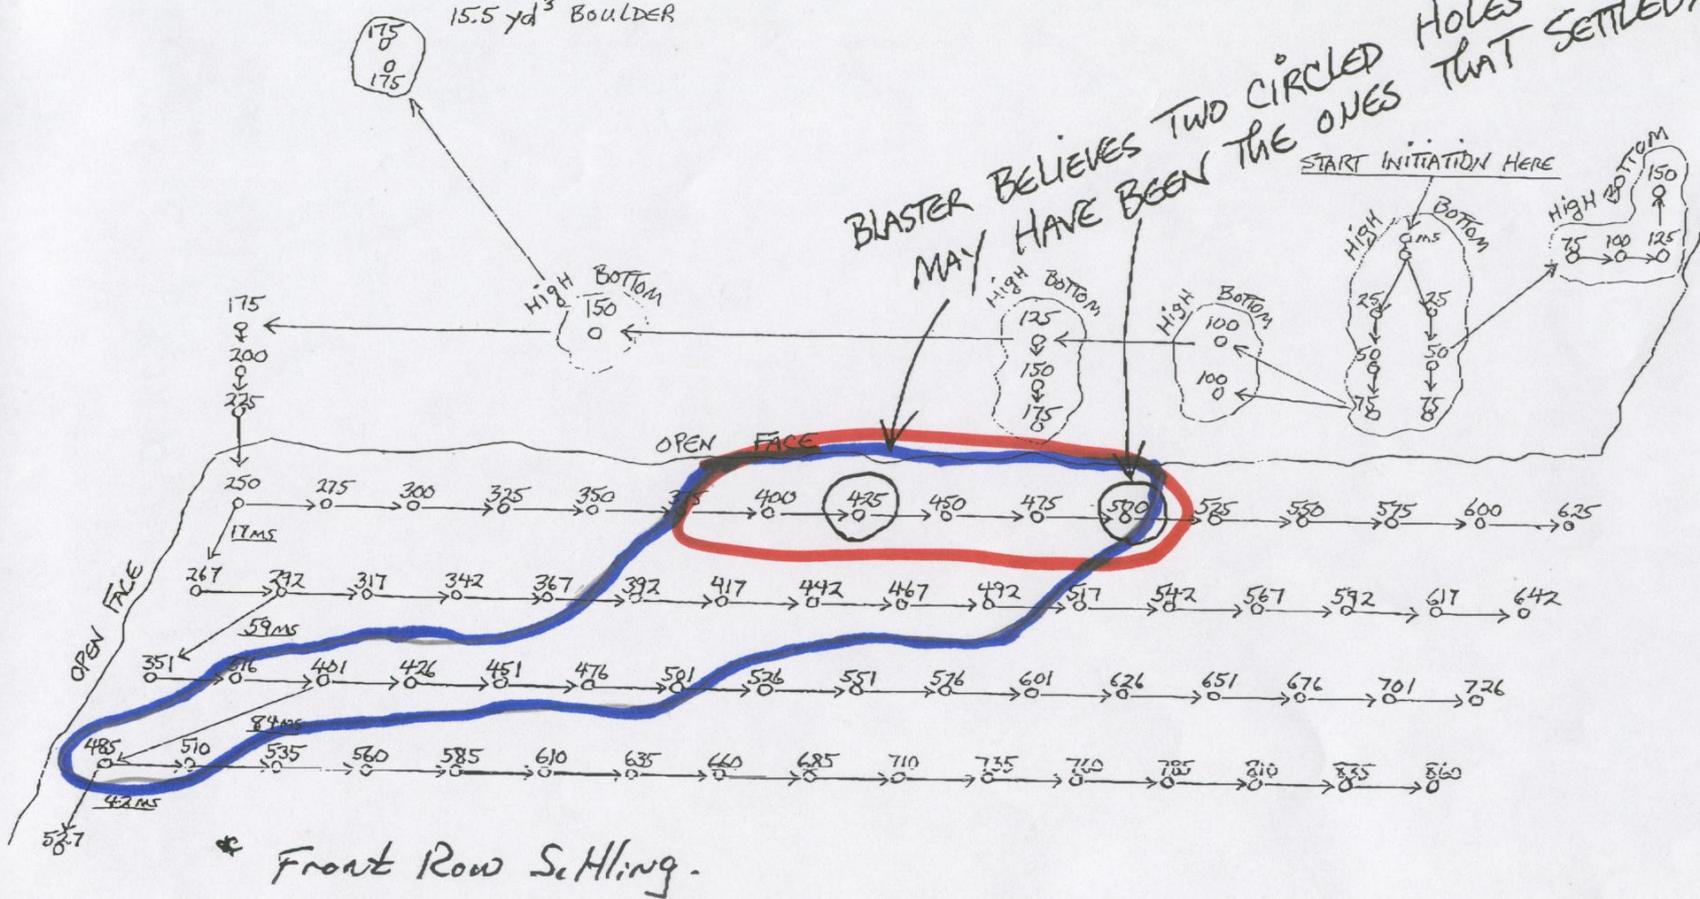
15.5 yd³ BOULDER

BLASTER BELIEVES TWO CIRCLED HOLES MAY HAVE BEEN THE ONES THAT SETTLED.

START INITIATION HERE

* Front Row Settling.

65 PRODUCTION HOLES - 4 1/2" DIA
58' DEPTH - FACE 54'

19 HIGH BOTTOM HOLES - 4" DIA
8' DEPTH

1 BOULDER 15 1/2 yd³
2 Holes

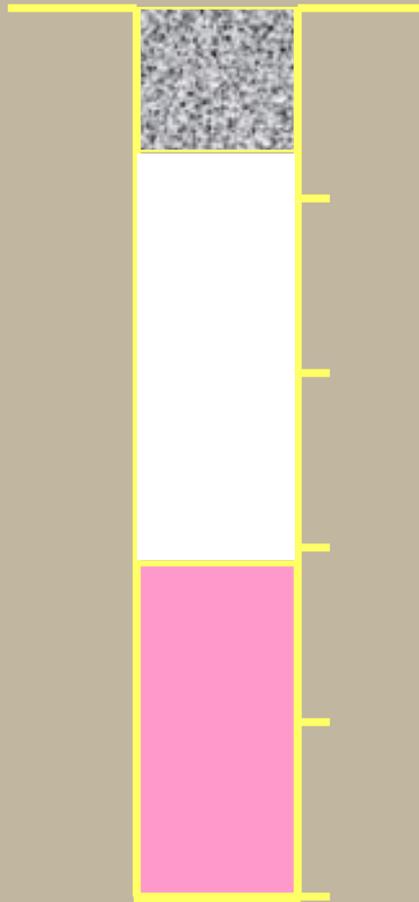
Maintaining a
p.f. of 1.31 with
Typical glass beaded
ANFO -Blend would be
a 13x16 pattern

Remember we started with a 12 X 14 pattern

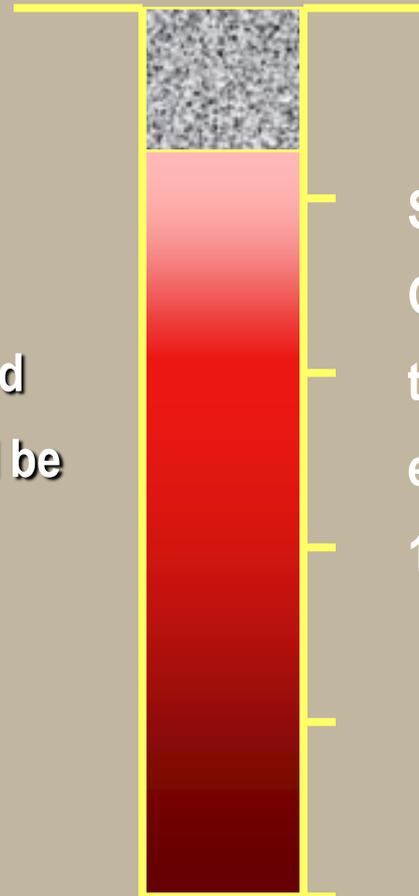
Same p.f. with
Gassed Emulsion
the Pattern could
expand to
12.5 x 15

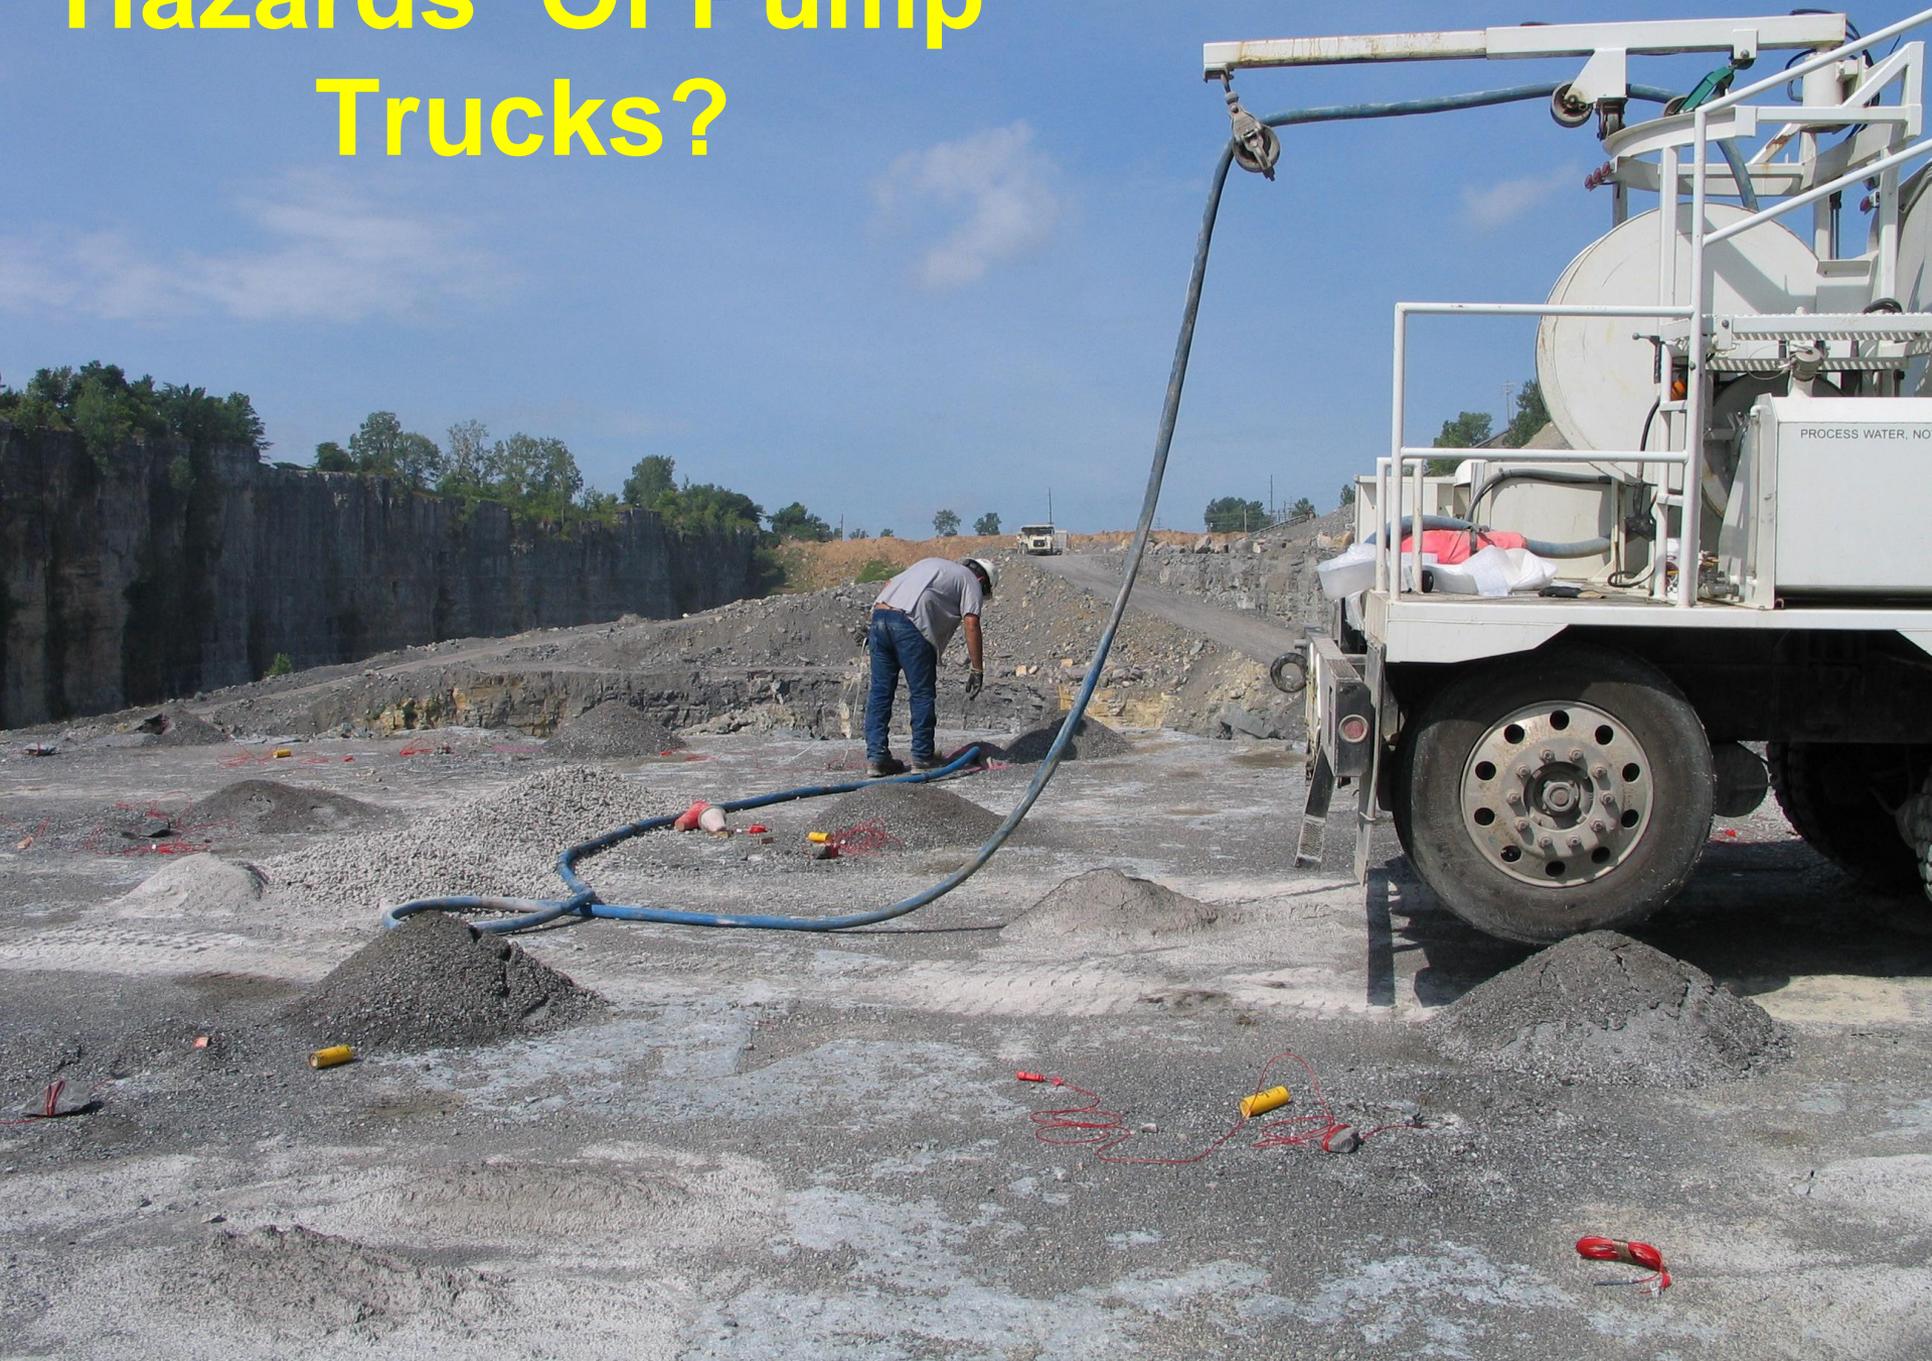
Progressive Cavity Pump!

Hazards' Of Pump Trucks?

??? 77.404(a)??? IME 3-4.1.1 (extracts from)

As a minimum requirement, protect against "dead-heading", dry running or high pressure conditions. Redundancy may be desired in the pumping system protective circuits and is recommended as a good practice.

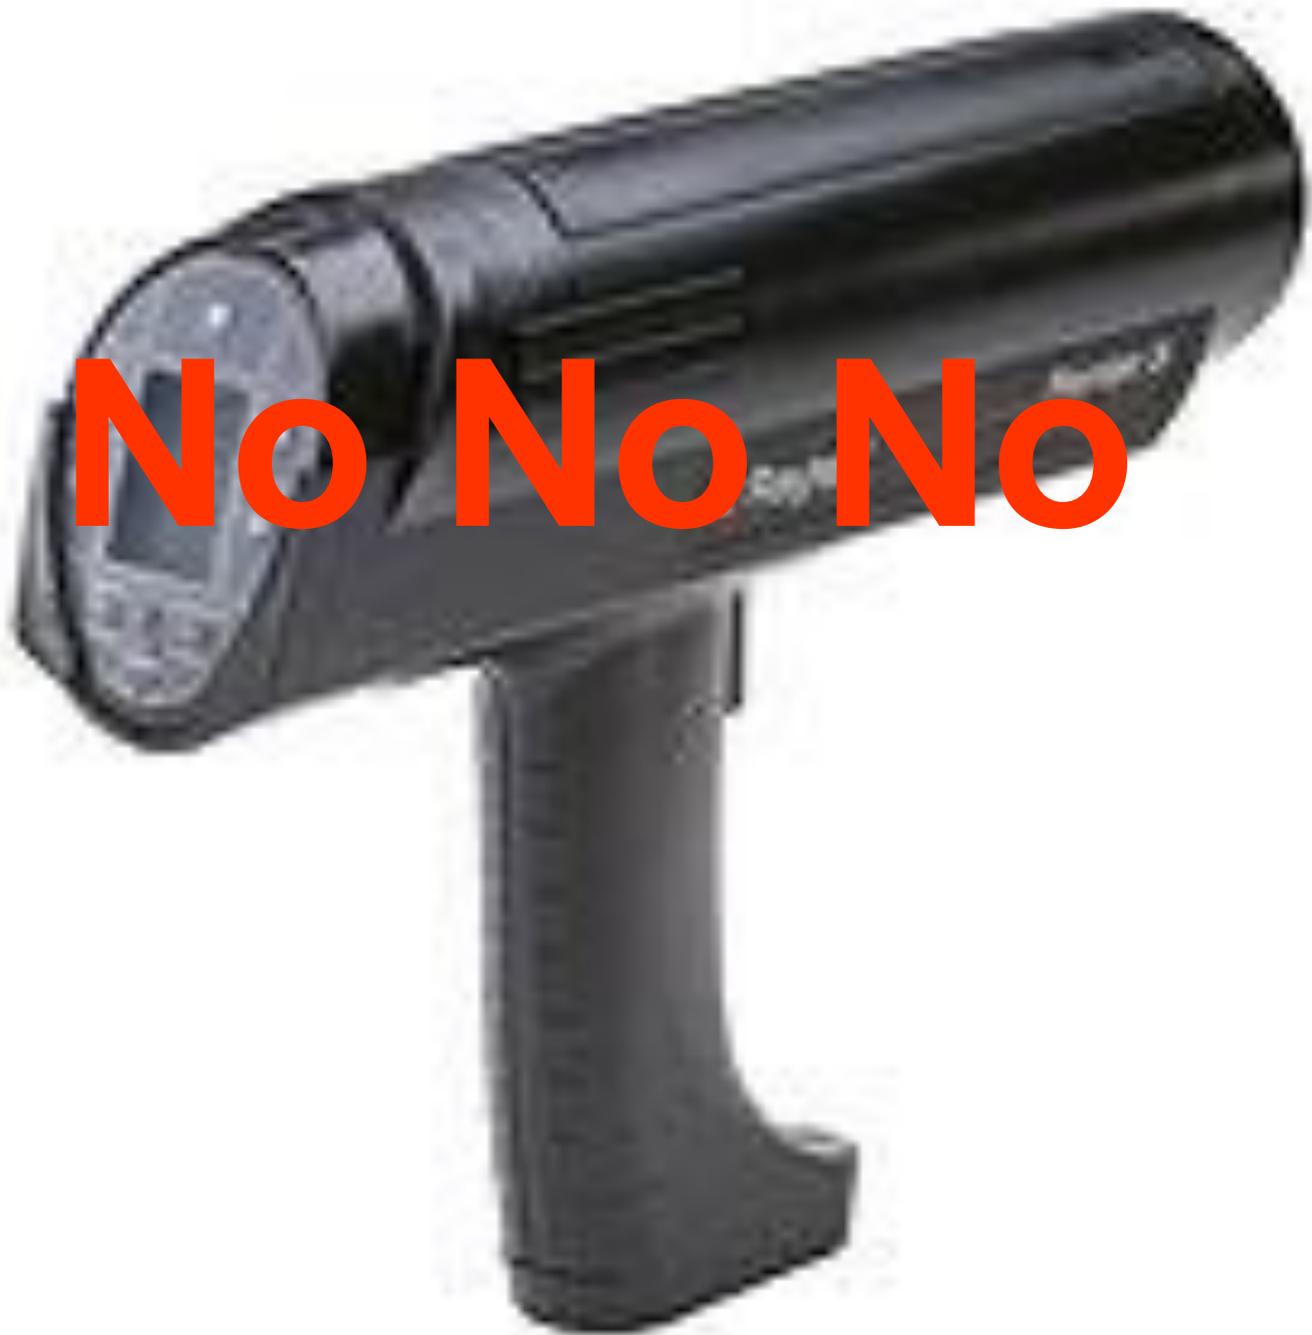
Tempilstik®

Temperature
Indicators

You know the
temperature
when the
chalk melts
